# **THE OPENING OF TECTONIC FRACTURES AT THE LANGALDA DAM**

**HAUKUR TÓMASSON**  
Head of Engineering Geology  
National Energy Authority  
ICELAND

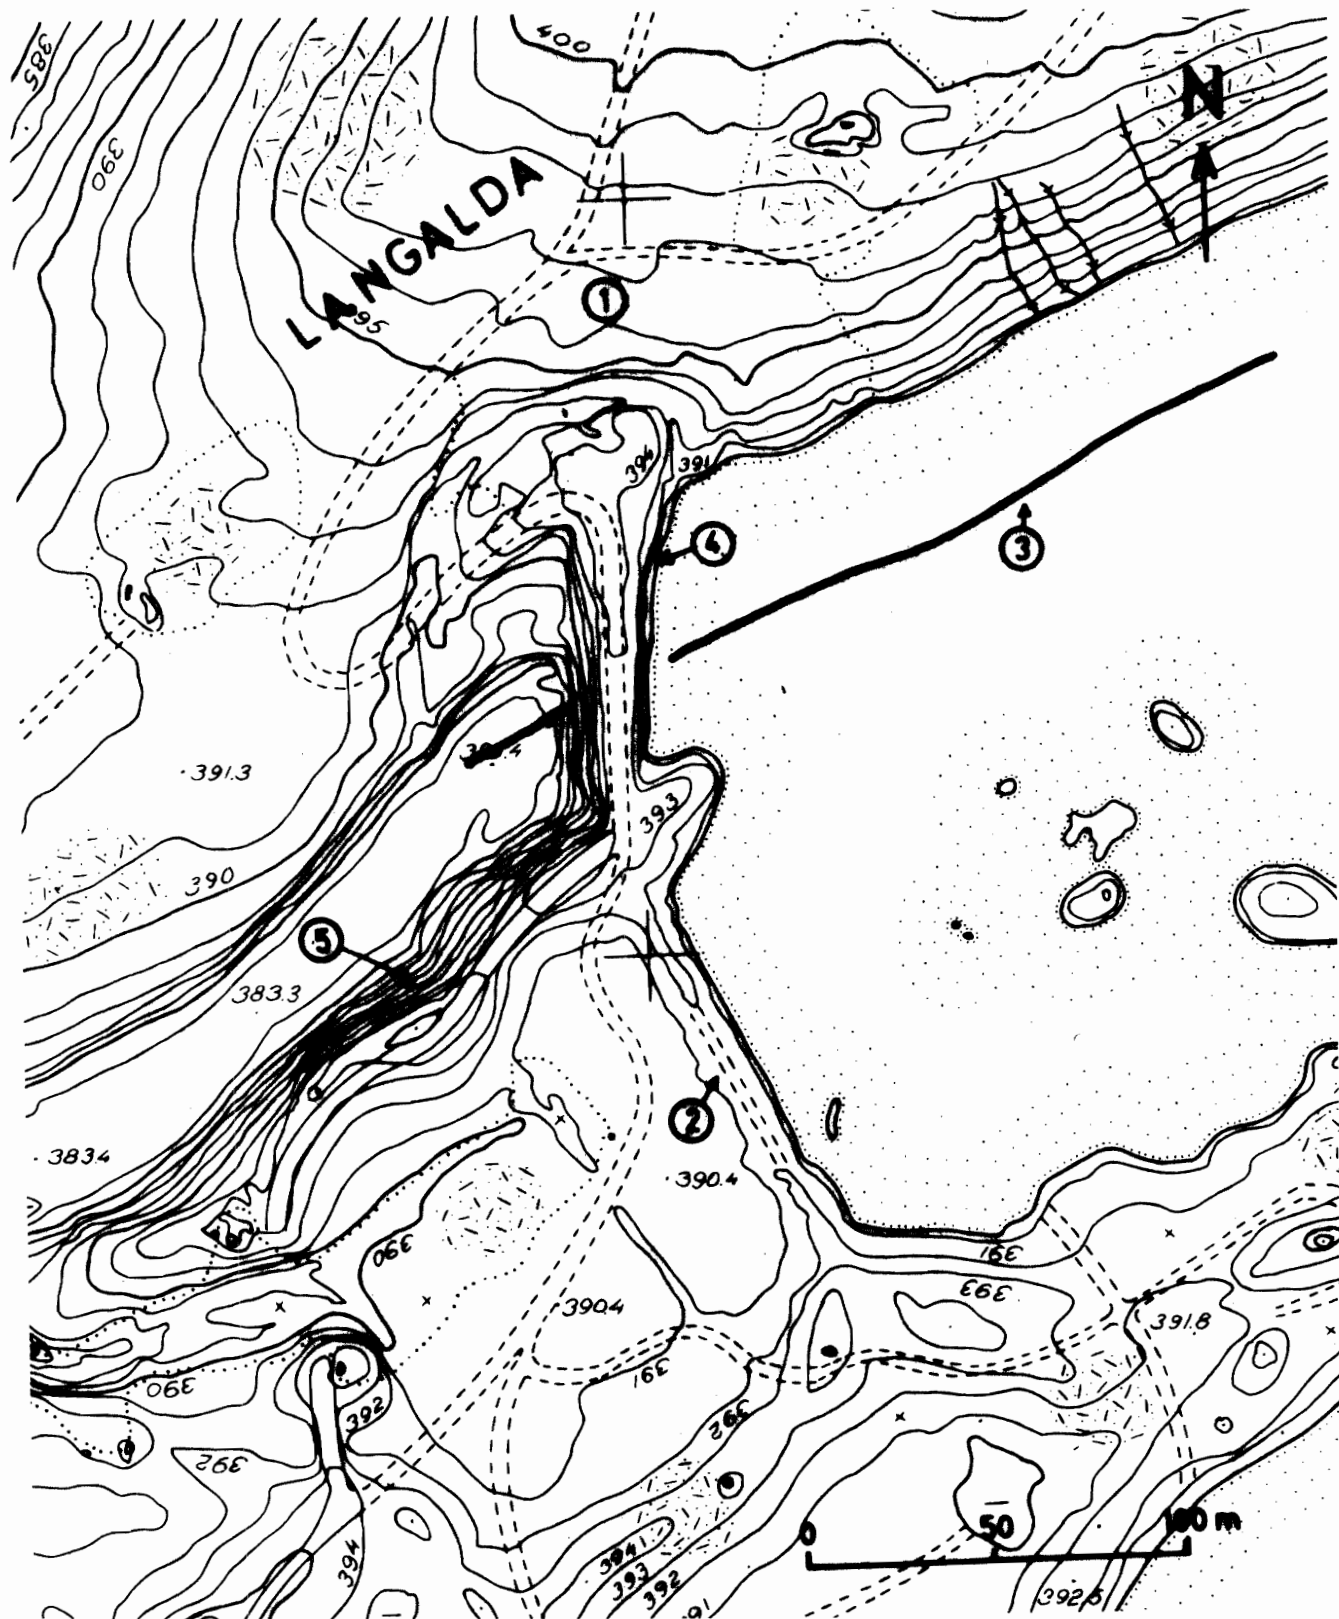
Figure 2

As a result of these steep slopes a slip fracture developed in the dam in 1970 when the water depth had been 3-4 m for a while. This fracture was parallel to the long axis of the dam and extended all along the highest part of it. A settlement of 10-20 cm took place in the upstream part of the dam.

Map with 1 m contour lines showing the dam and the lake approximately 7.5 m deep and fault under the dam. 1 Borrow area in Langalda. 2 Spillway on postglacial lava flows. 3 The fracture. 4 The main dam. 5 Lava front.

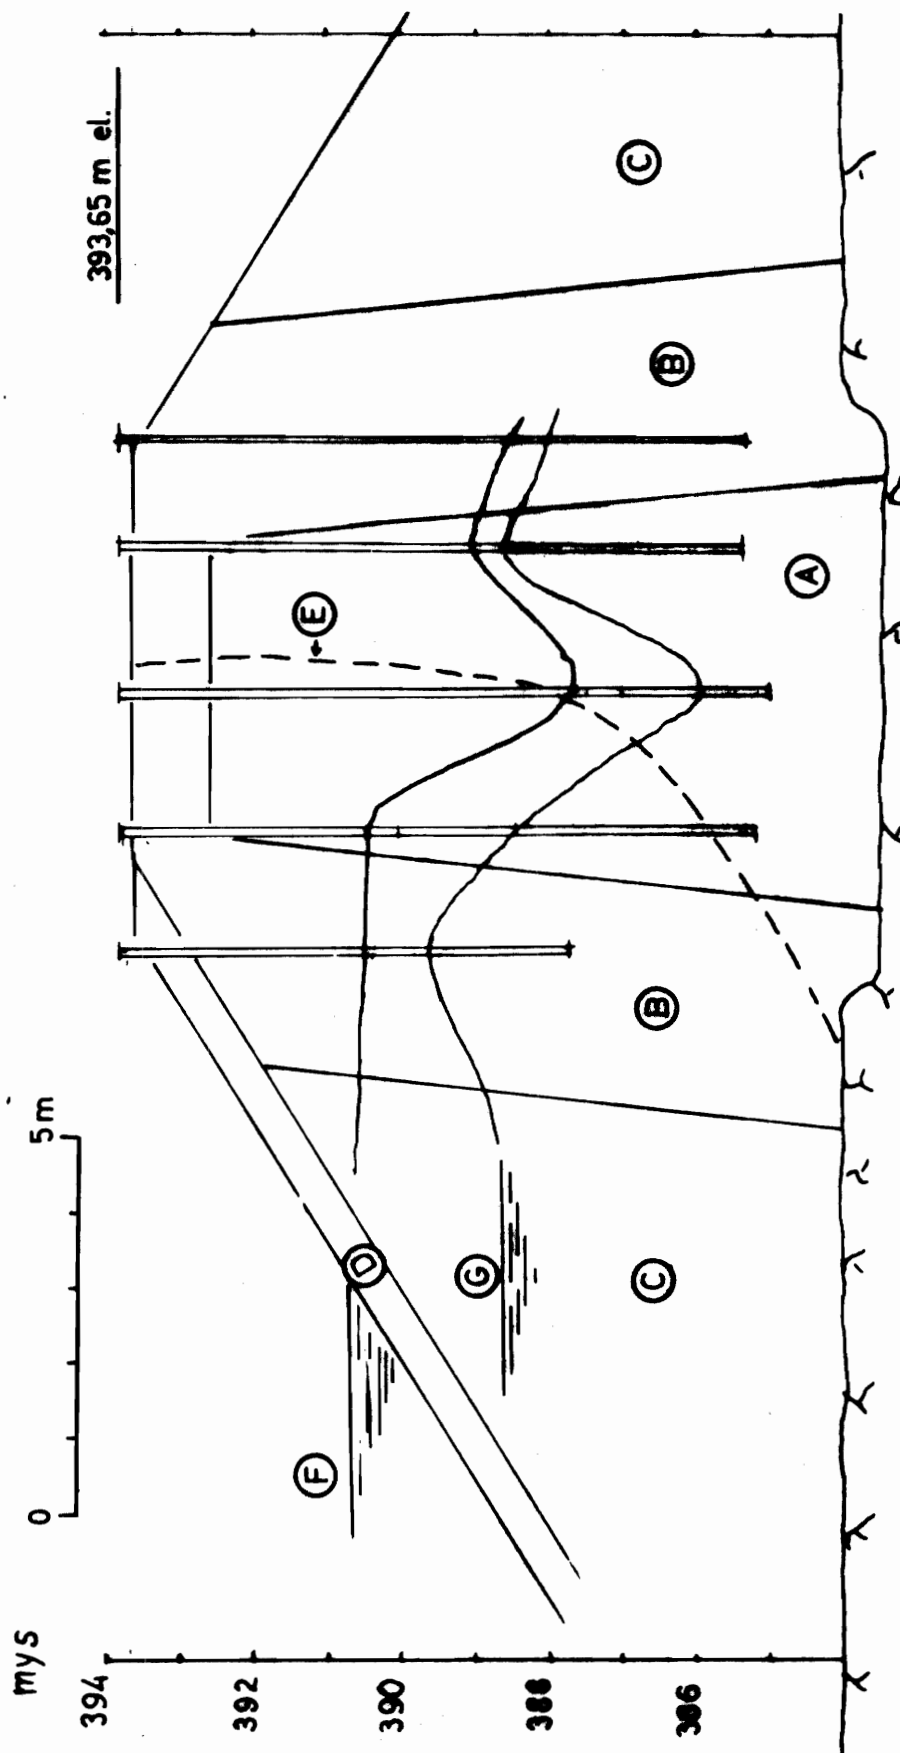
Figure 3

In 1972 6 piezometers were put into the dam. The result of drop in pore pressure is shown in fig. 3. The irregularity in the drop of piezometer readings is probably due to the fracture in the dam. Leakage through the dam seems to be small and of no concern. A short path leakage through the left abutment has occurred several times when the lake has reached a new peak in elevation and it has gradually decreased or disappeared when the lake level went slightly down again. No indication of piping has been observed.

Cross - section of the dam (intended)  
 with piezometers.

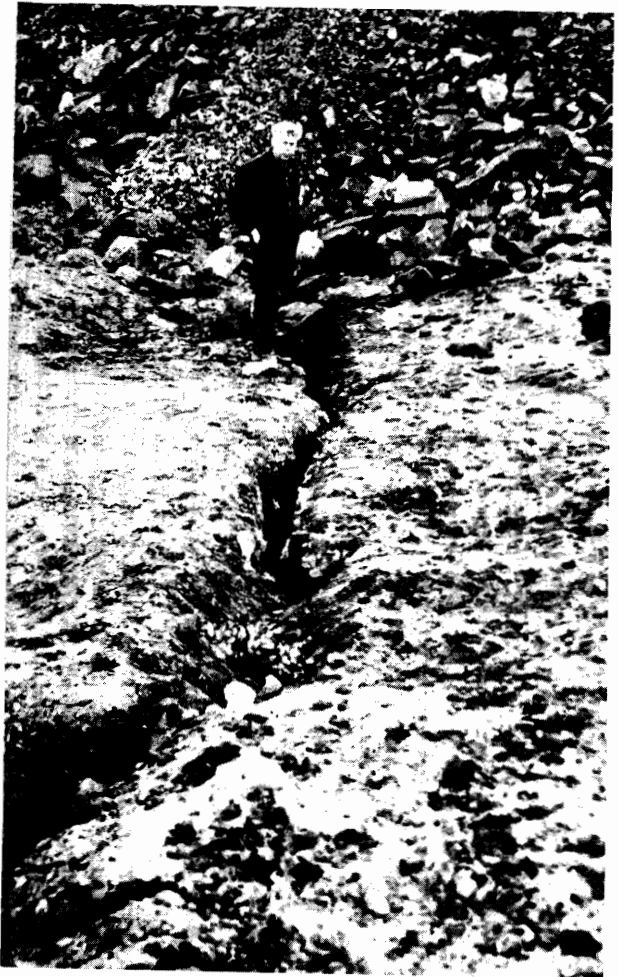
Figure 4

All these early fractures are situated in móberg (pillow lava or breccia) or overlying tillite. They can neither be detected on the surface of the young lava flows nor higher up in the Langalda hill above lake level. The water therefore plays an evident role in making this phenomenon so distinct. When the fractures open up the water washes down into them all loose material from the banks leaving the fractures clear as far down as can be seen, which is between 10 and 20 m. Figures 4 and 5 show the fractures at different places.

Each individual fracture seems to extend for almost 100 m, the width amounting to as much as 20 cm near the middle. Some of the fractures are evidently old, having old fillings on their inside walls, which when losing their support have caved in more or less. The remaining fracture fillings often indicate a divergence of 20 cm or so. The broadest fracture is about 70 cm wide of which nearly 50 cm constitute old filling. In the tillite the fracture planes frequently match accurately but a strike-slip or strike-dip movements can also be detected widely amounting to a few cm. The movement either vertical or horizontal seems to be at random.

The fracture where it disappears under the upstream toe of the dam.

The repair of the dam was started on the 17th of May by pumping down into the fracture under the dam a mixture of sand and bentonite. At the latest stage a cement bentonite mix was used until the fracture was full. The repair of the dam amounted to 2500 \$ in cost.

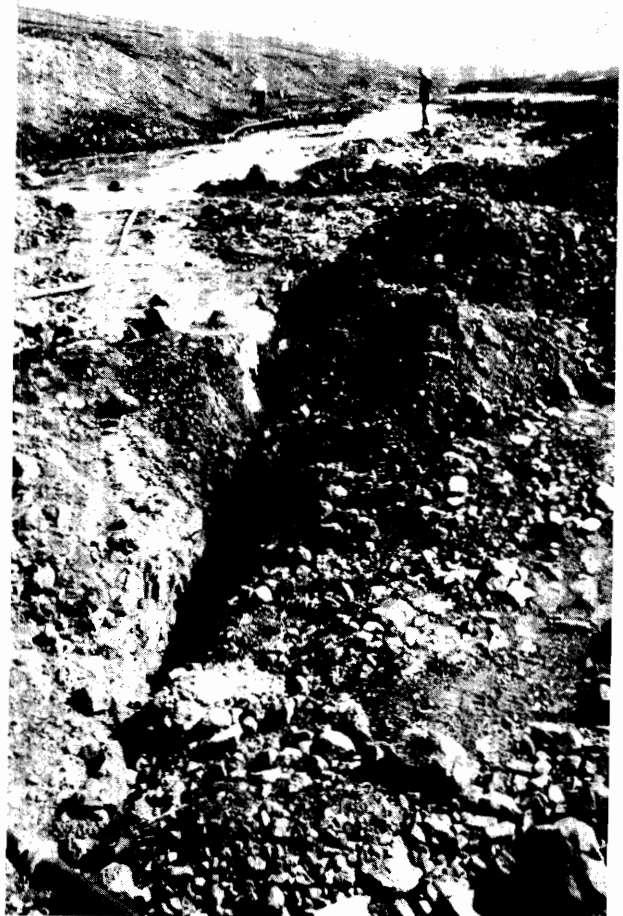
Figure 5

The fracture at a place where it is rather wide. In the foreground there is an old fracture filling loosened from both walls but not collapsed. A small brook is flowing into the fracture.

All the other fractures were filled with local material, mostly sand and moraine, packed with running water that was either pumped or one used the small inflow of water into the reservoir to do this. A suitable filter material was not found nearby and it was therefore too expensive to haul it in. But certainly a fracture should be filled with filter material as swallow holes are if the best results are to be obtained. About 300 m<sup>3</sup> of sand and moraine was used to fill up the fractures.

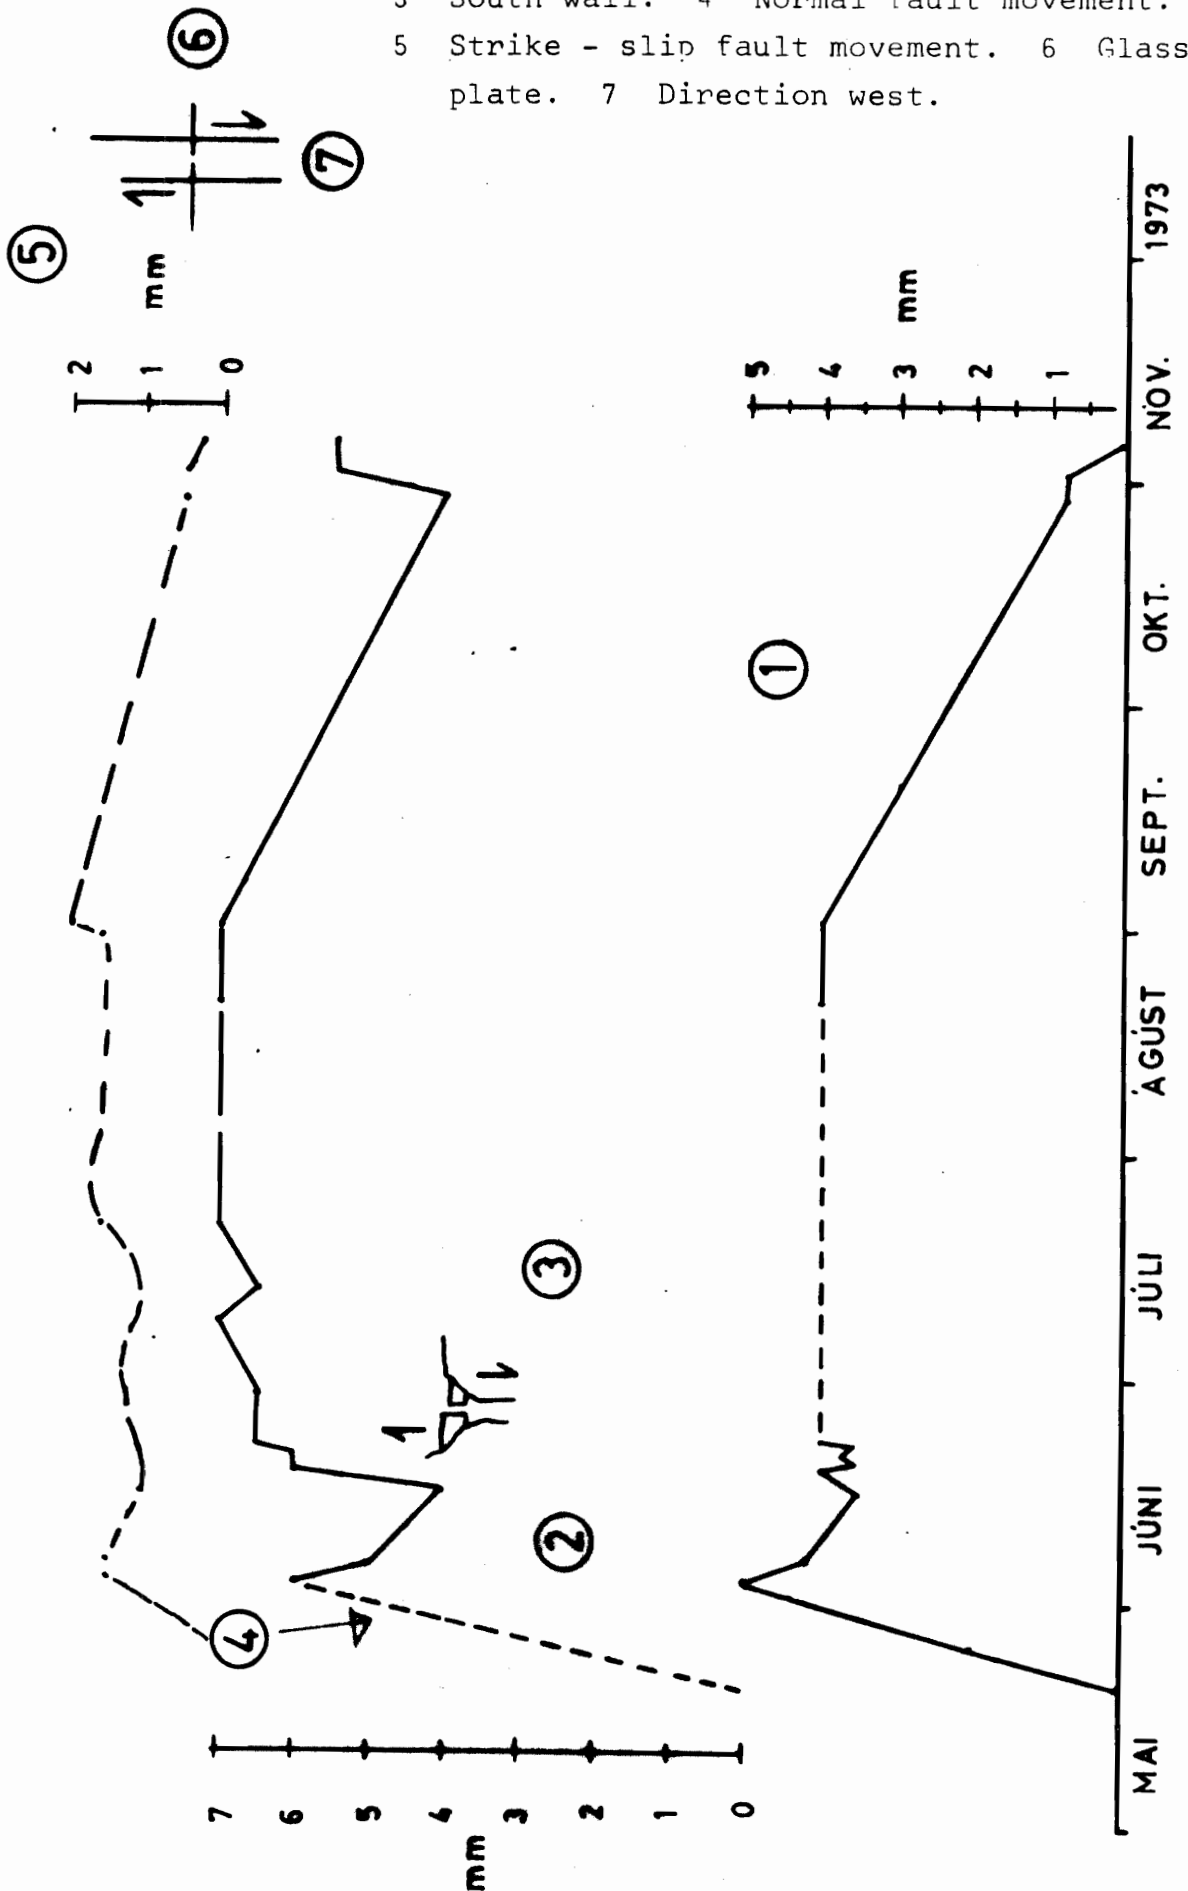
Figure 6

Downstream of the dam the behaviour of the fracture has been studied. In 1971 nothing more happened there but in the spring of 1972 the glass plates broke and the fracture was extended several tens of meters further downstream. No leakage due to this was observed. The widening of the fracture was about 3 mm. New glass plates were concreted across the fracture.

In 1973 some small movement was recorded; about 4-5 mm widening of the fracture in the spring and then contraction in the fall when lake level was falling. Small components of normal faulting and strike slip faults could be discerned. The result of these measurements are shown in fig. 6.

The movement of the fault downstream of the dam and changes in positions of glass plates concreted across it in 1972.

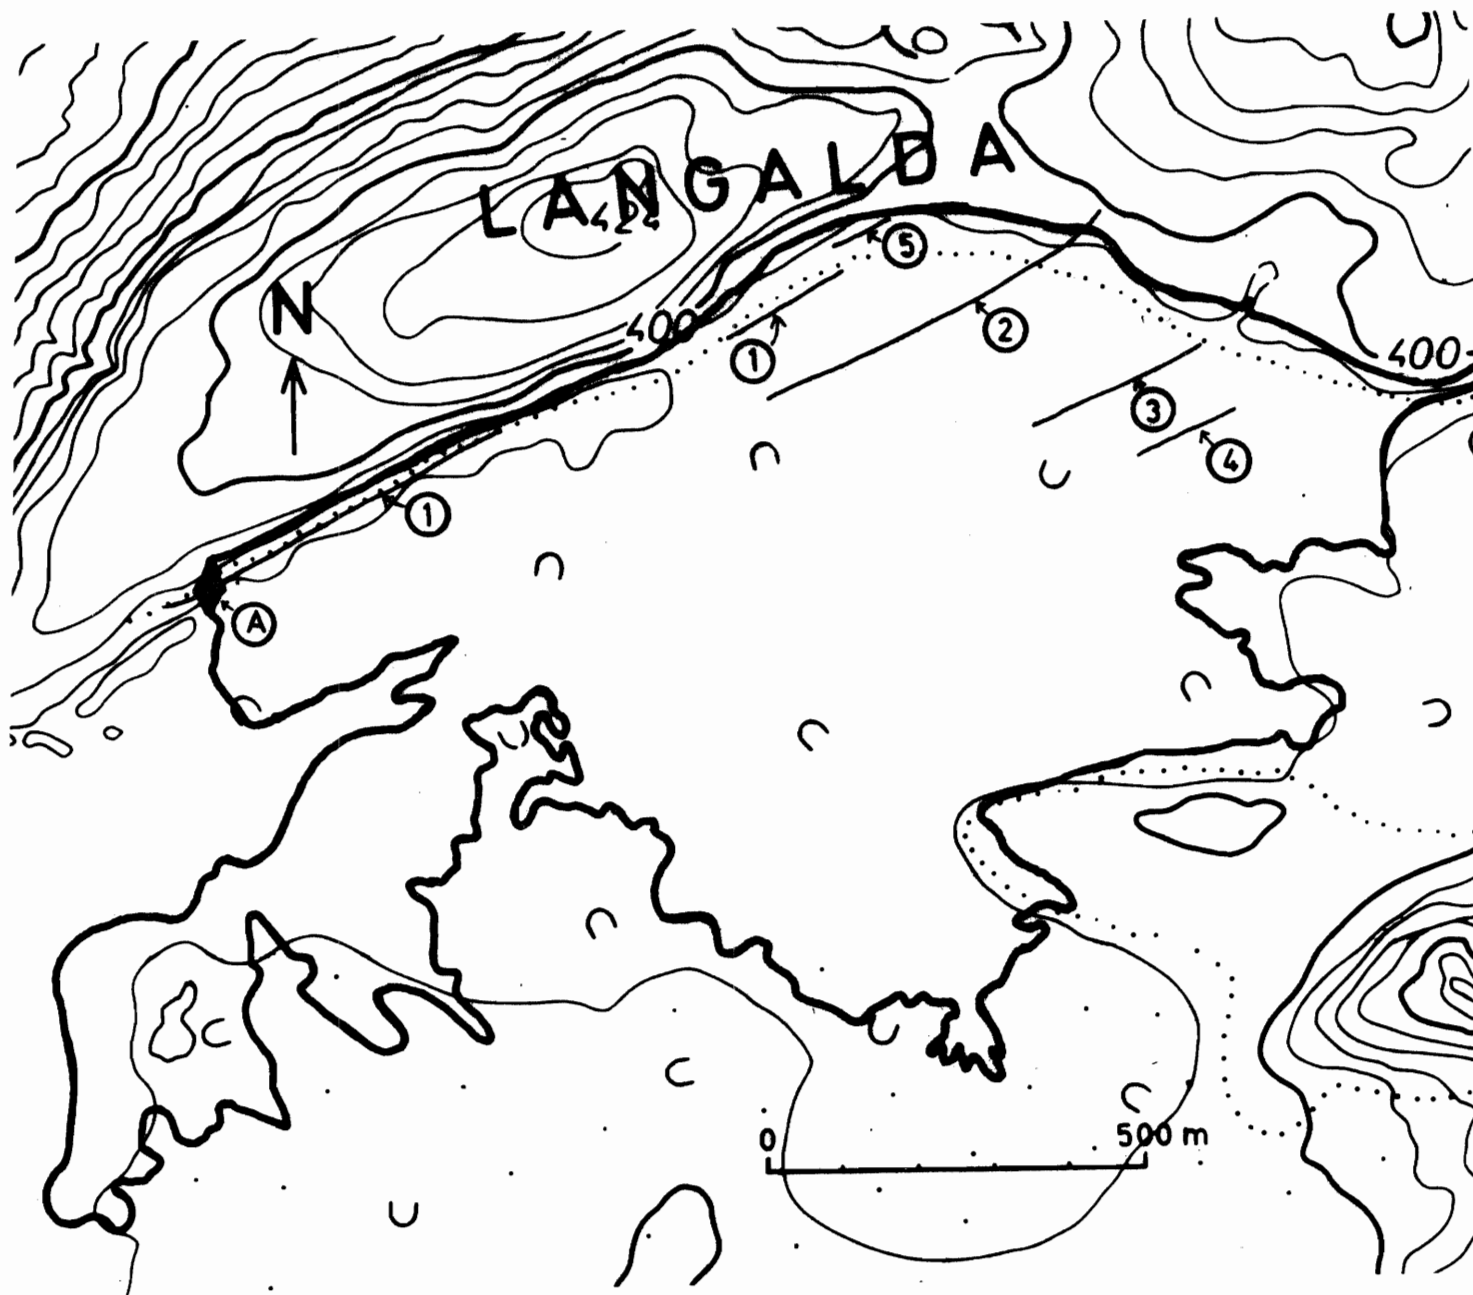
Figure 7

Several other faults did open in the Langölduveita lake bottom. The biggest one no. 2 on the map figure 7 opened up in September 1972. It extended about 100 m up on dry land and this made observation possible. Sudden increase in leakage recorded in continuous stage records in lake and inflow indicate that the fault was found 1 or 2 days after it was formed. These later faults were formed both in móberg and the postglacial lava. They are probably new in the postglacial lavas as old fracture fillings were not observed there. But in the móberg underneath these are certainly old faults in most cases. The faults no. 3, 4 and 5 were found when lake level was lowered in 1972 to repair swallow holes and to repair fault no. 2. At this time it was obvious that fault no. 1 was practically tight as the lake level did not go much below the lowest point of fracture no. 2 although no inflow was allowed for several days. Figure 8 shows fault no. 2.

The Langalda test reservoir 7,5 m deep A The dam, 1 The first fracture found in April 1971; 2 The fracture found in September 1972; 3 and 4 were found when lake level was lowered in September 1972; 5 was found at a low lake level in May 1972.

The other faults were repaired in similar manner as the first one, except we tried to use canvas as an artificial filter, to decrease the transport by lorries of filter material into the dry lake bottom, but that is very difficult due to the slippery silt layer. The results indicate that this is sound reasoning, although nylon filter would be stronger and more durable and should be used in actual practice. Absolutely impervious blankets such as plastic sheet can only be used with good results on solid rock, as piping does always occur along the edges of plastic sheets if placed on loose material. Pervious filter is recommended in order to minimize the dependence on the natural sealing process for decreasing the leakage.

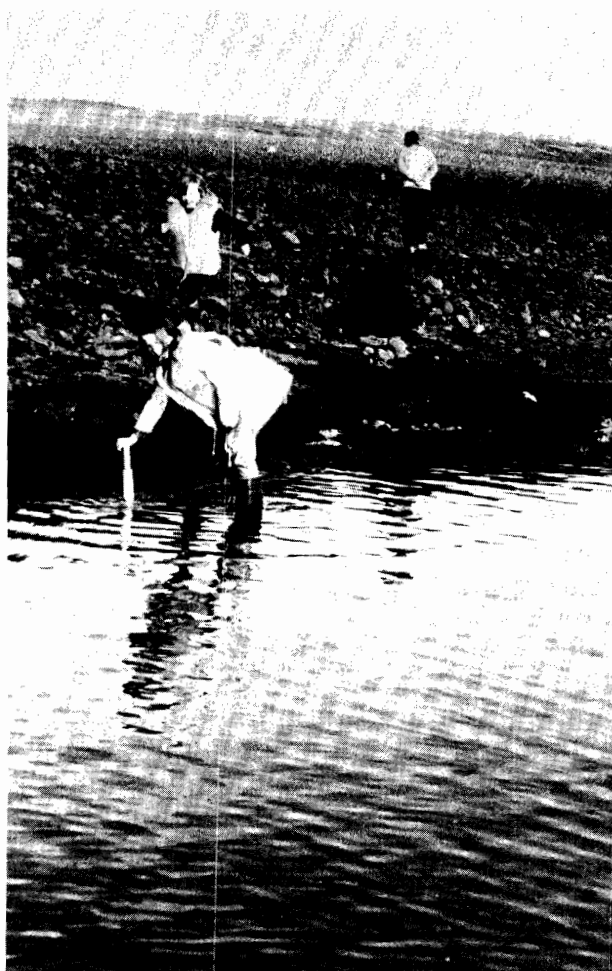
The fracture which opened up in September 1972. Photograph taken where it extends up to dry land.

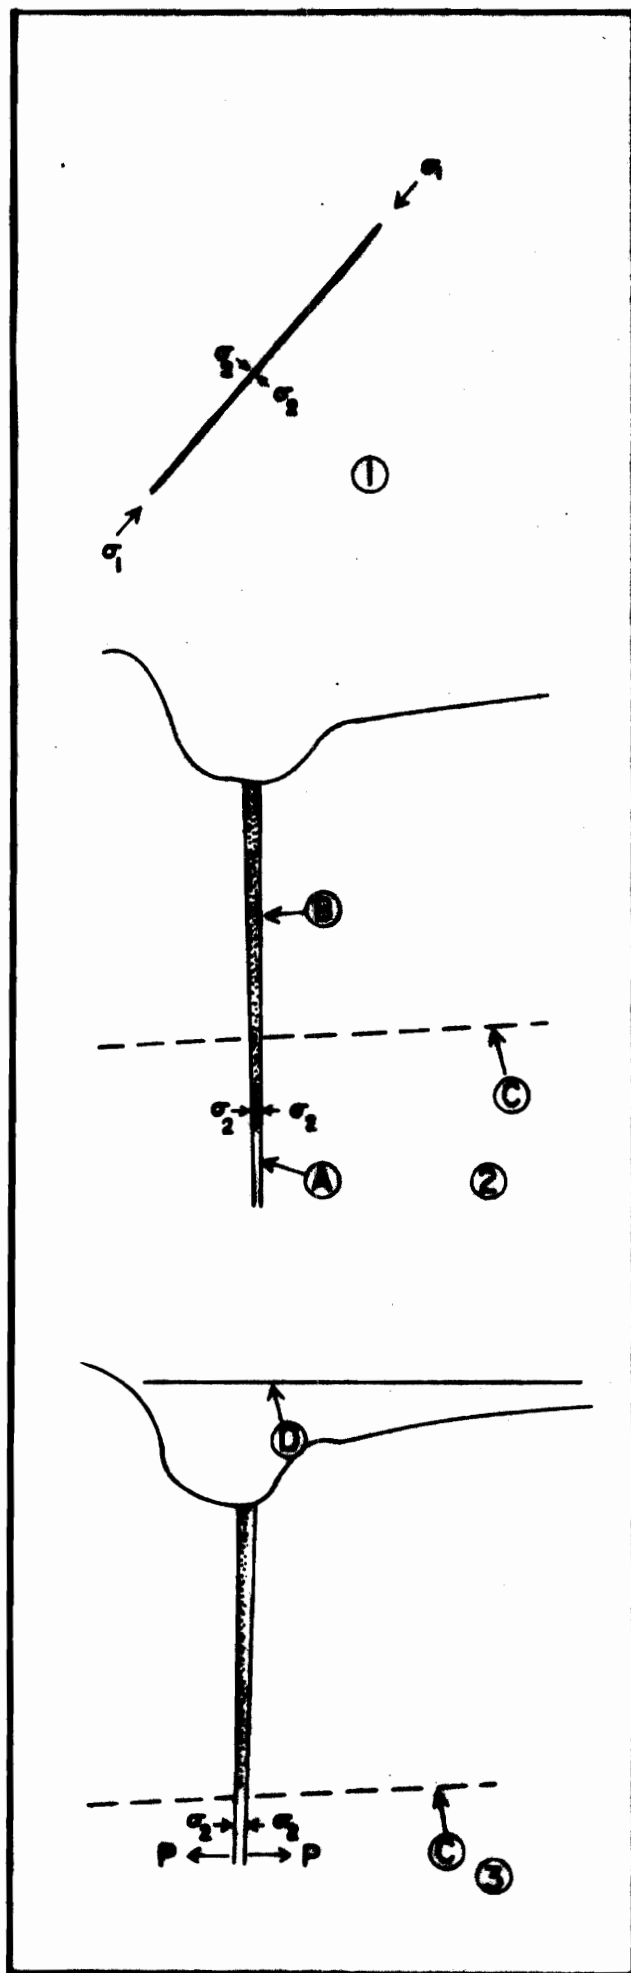
Figure 10

- 1 Plan sketch showing a fault, probably an old normal fault, with stress condition as shown.  $\sigma$  are the principal horizontal stresses.
- 2 Cross section across the fault before water is put on. A is relatively open fault below B, a fault filling which has been washed into the fault when it was an open fracture. C ground water table.
- 3 Shows the same as above after water is put on. D is lake level. P is hydrostatic pressure in the relatively open fault. This pressure is the same as the head from lake level down to ground water level. It is greater than the minimum horizontal stress. The result is widening of the fault.

In fig. 10 there is an effort to explain this further. The fault has a lower principal horizontal stress perpendicular to the faultplane but higher principal stress along the faultplane. The fault is an old normal fault. At that time the lower stress was tension. The lower stress is still very small or of the order of magnitude  $1-2 \text{ kp/cm}^2$ . The geological condition is such that ground water level is far below surface or 20-30 m. For some reason an opening is formed in the fault filling, where it is weakest. This opening can start as piping but when the contact is made with the lake the hydrostatic pressure at the faultplanes exceeds the horizontal stress and the fault opens up.
