UNITED NATIONS
UNIVERSITY

Geothermal Training Programme

Reports 2018
Number 8

ANALYSIS OF STUCK PIPE AND FISHING OPERATIONS: CASE STUDY OF OLKARIA GEOTHERMAL FIELD IN KENYA

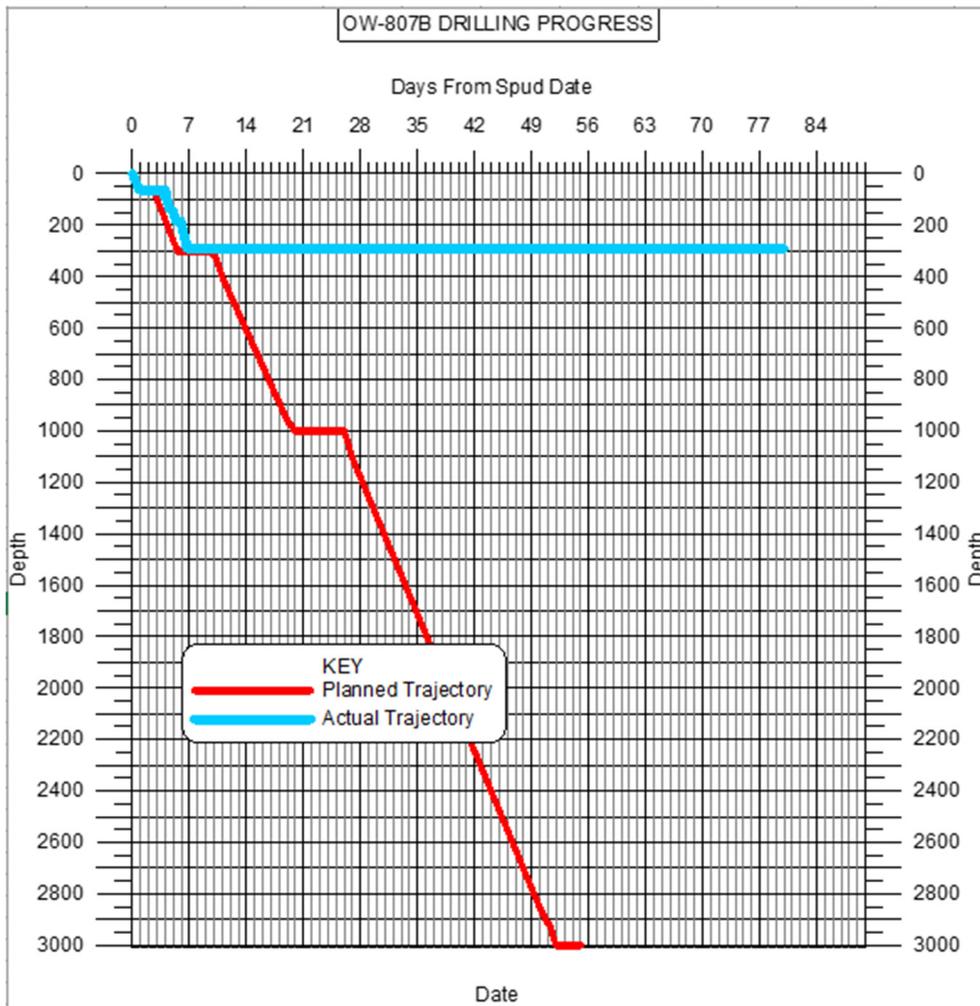
FIGURE 6: Well OW-807B drilling progress (KenGen, 2018)

The upper section of the hole was in a zone of unconsolidated pyroclastic materials consisting of pumice, tuff, volcanic ash and lithic rock fragments in which cave-ins were expected. Rhyolites, tuffs and minor basalts formed the intermediate zone between 140 m and 300 m depth. The soft formation contains pieces of hard blocks. Circulation losses were also expected in this region. The drilling parameters and rock types are shown in Table 4.

The first incidence of a stuck pipe (at 204 m) occurred while a connection was made. Given that there were no circulation returns and the formation was unconsolidated, possible causes of the stuck pipe are summarized in Table 5:

MD (m RKB)	Changes in torque	Changes in WOB	Changes in ROP	Circulation returns	Stuck pipe indication	Possible cause of stuck pipe
204	During connection	During connection	During connection	No returns until air package was introduced	Drag on pulling	Pack-off caused by poor hole cleaning. Cuttings settled during connection packing off the BHA.
290	Increase	Unchanged	Unchanged	There were circulation returns but were lost after the stuck pipe incidence	Increase in torque which slowed down RPM to 0	The unconsolidated formation could have resulted in cave-in and subsequently solid pack off.

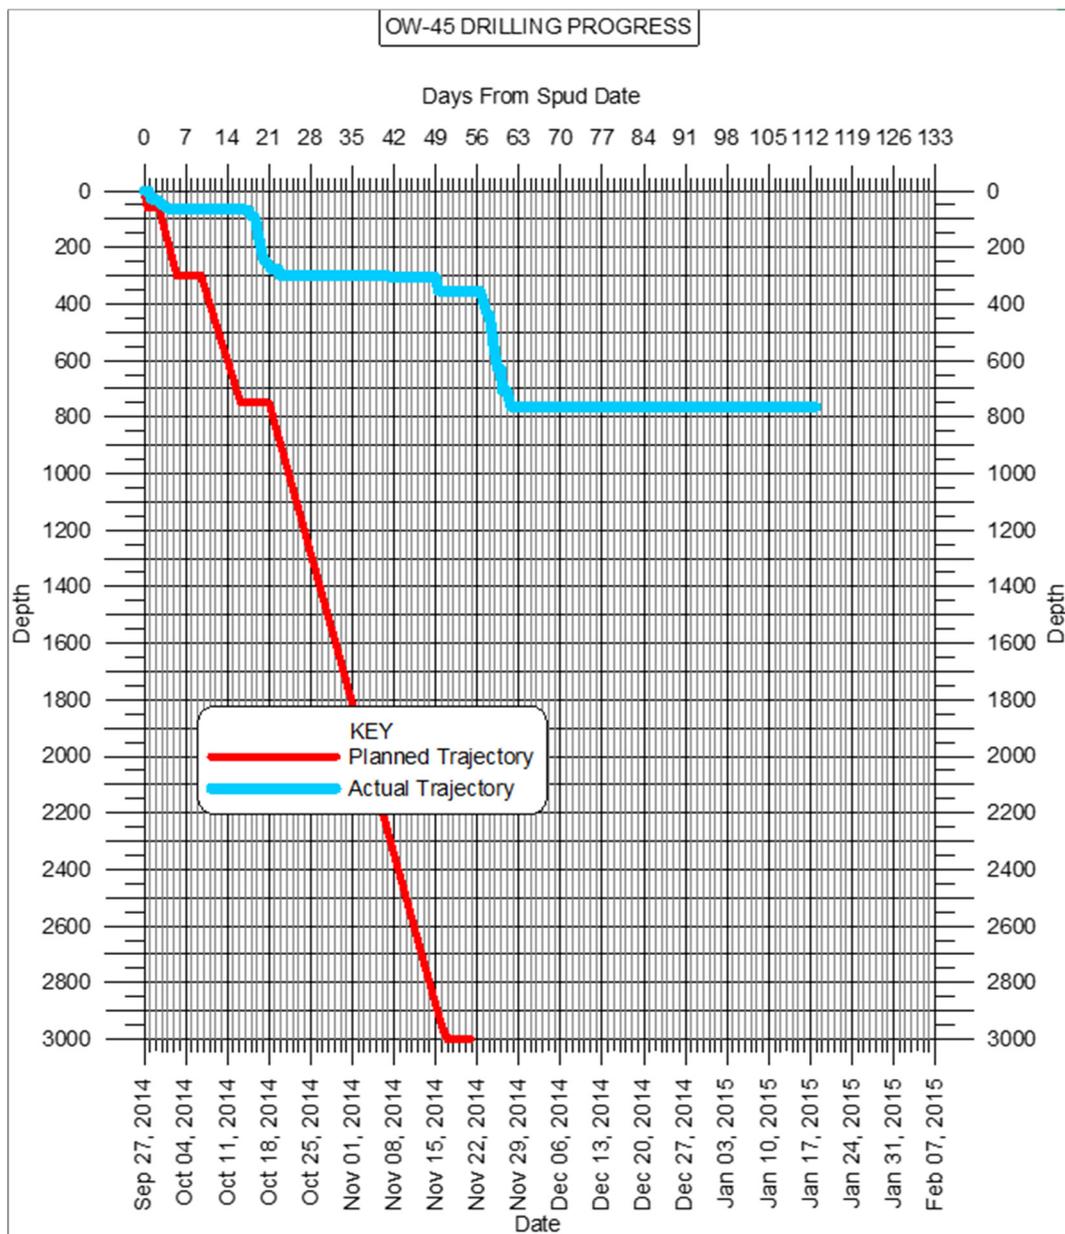
FIGURE 7: Well OW-45 drilling progress (KenGen, 2015)

The critical section is in a zone of unconsolidated formation made up of mainly pyroclastic and rhyolitic rocks. Most of the circulation fluid is lost in these formations and therefore the hole cleaning capacity is compromised. The unconsolidated nature of formation meant that cave-ins were frequent and could have caused the stuck pipe.

The cause of the stuck pipe in this case could be attributed to unconsolidated formation leading to solid pack-off or ledges. The stuck pipe occurred while tripping out of the hole to change the bit and therefore

the circulation was cut off. This could have caused the settling of cuttings or the cave-in of the soft formation. High trip out speeds could also have led to suction pressure in the wellbore and therefore cave-ins. The alternating formation strength between rhyolites and pyroclastic rock could have led to formation of ledges and consequently caused the stuck pipe while tripping out of the hole.

For this particular well, it took a long time to establish circulation through the drill string and this could have worsened the stuck pipe condition. Lack of fishing tools like jars also complicated the matter. Running a 6" bit on 3½" drill string in hole to wash through the annular is not a recommended practice and it resulted in a second fish in the hole. Many days were spent to conduct fishing operation which was not successful in the end. The fishing string was not fit for the job as it kept on snapping at different positions during the fishing operation. Downhole equipment inspection ought to have been done prior to running in hole.

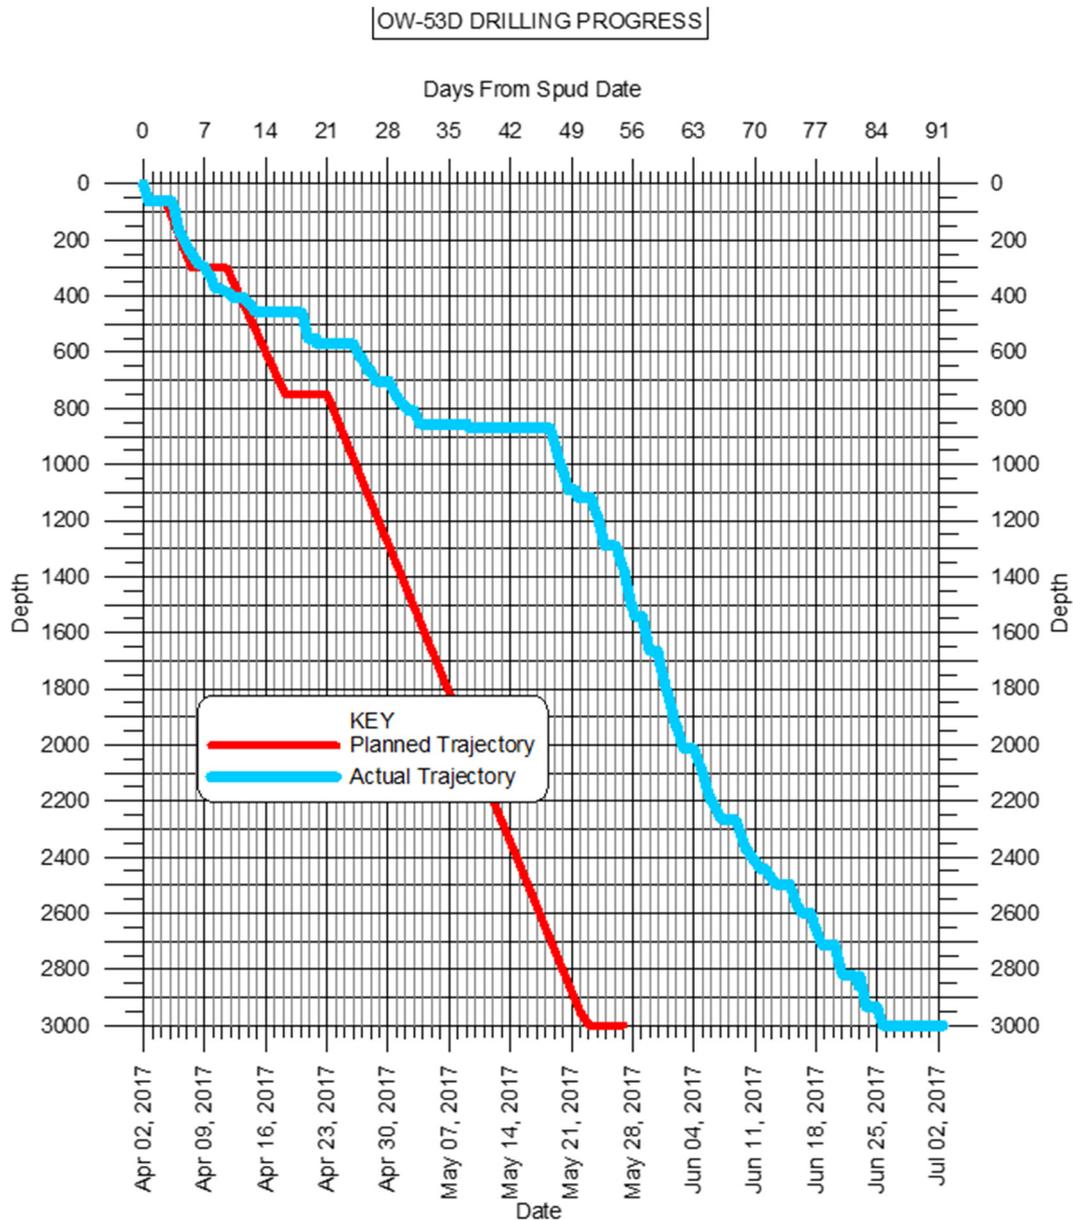
FIGURE 8: Well OW-53D drilling progress (KenGen, 2017)

MD (m RKB)	Changes in torque	Changes in WOB	Changes in ROP	Circulation returns	Stuck pipe indication	Possible cause of stuck pipe
568	Unchanged	Reduced	Reduced	Present	ROP reduced to zero despite increase in WOB	Pack-off caused by the swelling clays
871	Increase	Unchanged	Reduced	present	Increase in torque which slowed down RPM to 0	Solids pack off caused by cement boulders having drilled 250 m of cement column and/or reduction of well size due to swelling clays

For the first stuck pipe incidence at 558 m RKB, the possible cause could be attributed to swelling clays. Smectite clays were present in the formation. Due to kick off, the rate of penetration was low and this could have increased the exposure of water to clays causing them to swell inside the wellbore. For the stuck pipe incidence at 871 m RKB, the cause could be attributed to geometry of the wellbore since there were smectite clays that could swell on exposure to water.

Fishing operation for the two stuck pipe incidences was successful, however, a lot of time was spent to free the stuck pipe. The inability to back off at the desired depths led to extended length of fish in hole and made fishing operations more complicated. The surface equipment repairs that were done on the top drive could also have worsened the situation. Integrity of the down hole equipment was a notable factor. The fishing string snapped on various occasions leaving a second or more complicated fish in hole.

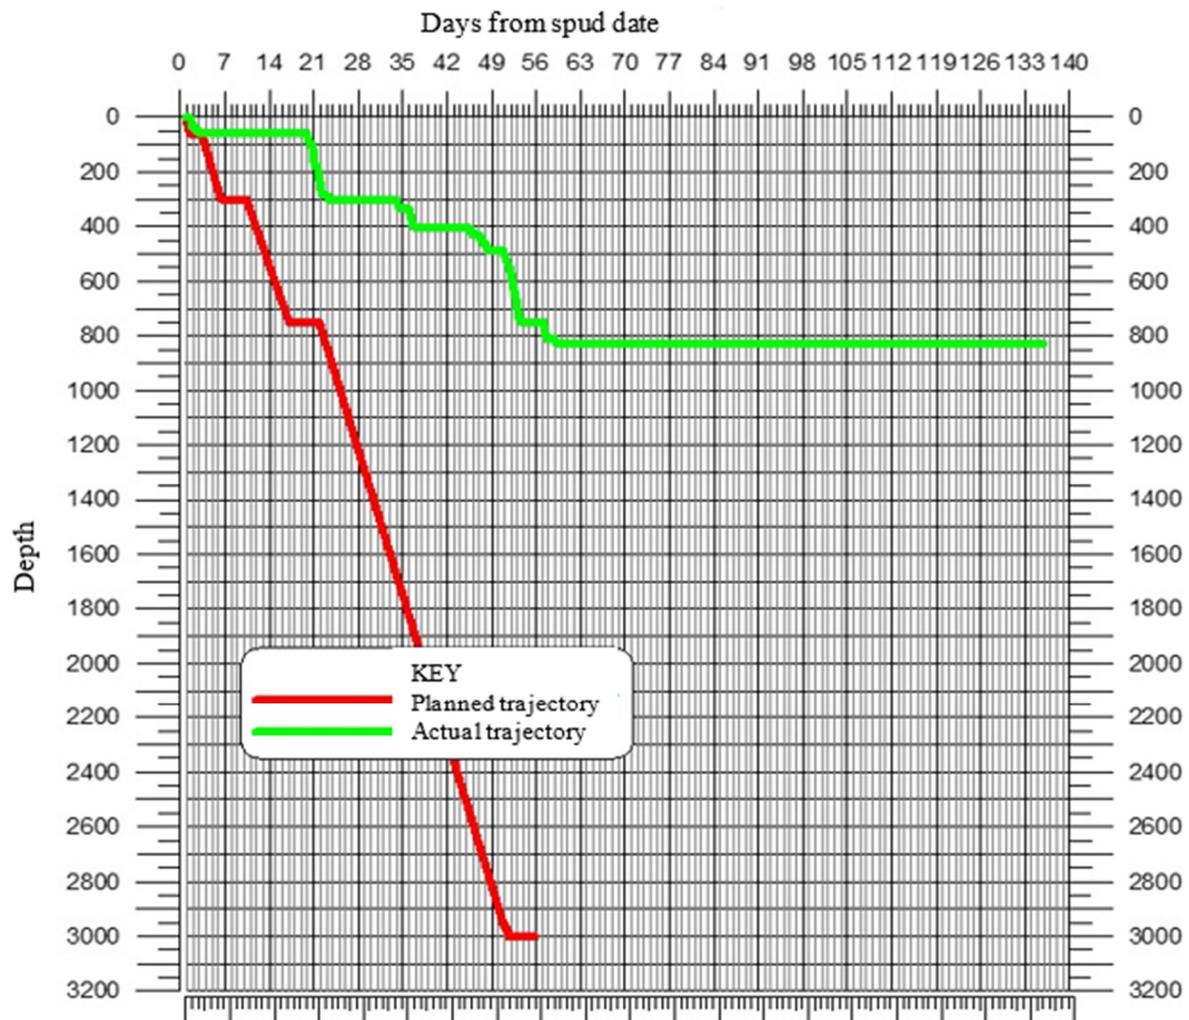
FIGURE 9: Well OW-905B drilling progress (KenGen, 2014)

MD (m RKB)	Changes in torque	Changes in WOB	Changes in ROP	Circulation returns	Stuck pipe indication	Possible cause of stuck pipe
811	Unchanged	Unchanged	Unchanged	Present	After making a connection, string could not move or rotate	Pack-off caused by clays and unconsolidated formation
829	Unchanged	Unchanged	Reduced	present	No string movement after completing repairs of surface equipment	Pack-off caused by clays and unconsolidated formation

The two incidences of a stuck pipe could be attributed to solids pack off. Swelling clays were noticed in the cuttings and could have caused frequent obstructions during tripping in hole. The soft to medium formation of rhyolitic tuff and pyroclastic could have also contributed to the solid pack off problem. It took approximately 10 minutes to make a connection. Repairs of the surface equipment (generator, submersible pump and top drive) were carried out while the BHA was at the bottom of the well. At this point (829 m), circulation was cut off and this could have led to wall collapse and subsequent pack off on the BHA. Stiff angle holding BHA of two stabilizers between two short collars could also have contributed to sticking.

There was malfunction of surface equipment during the fishing process. The draw works failed and had to be attended for 6 hours. The top drive also failed on several occasions. Proper maintenance of all surface equipment prior to fishing operations would have helped to save time and minimize complication during the fishing operations.

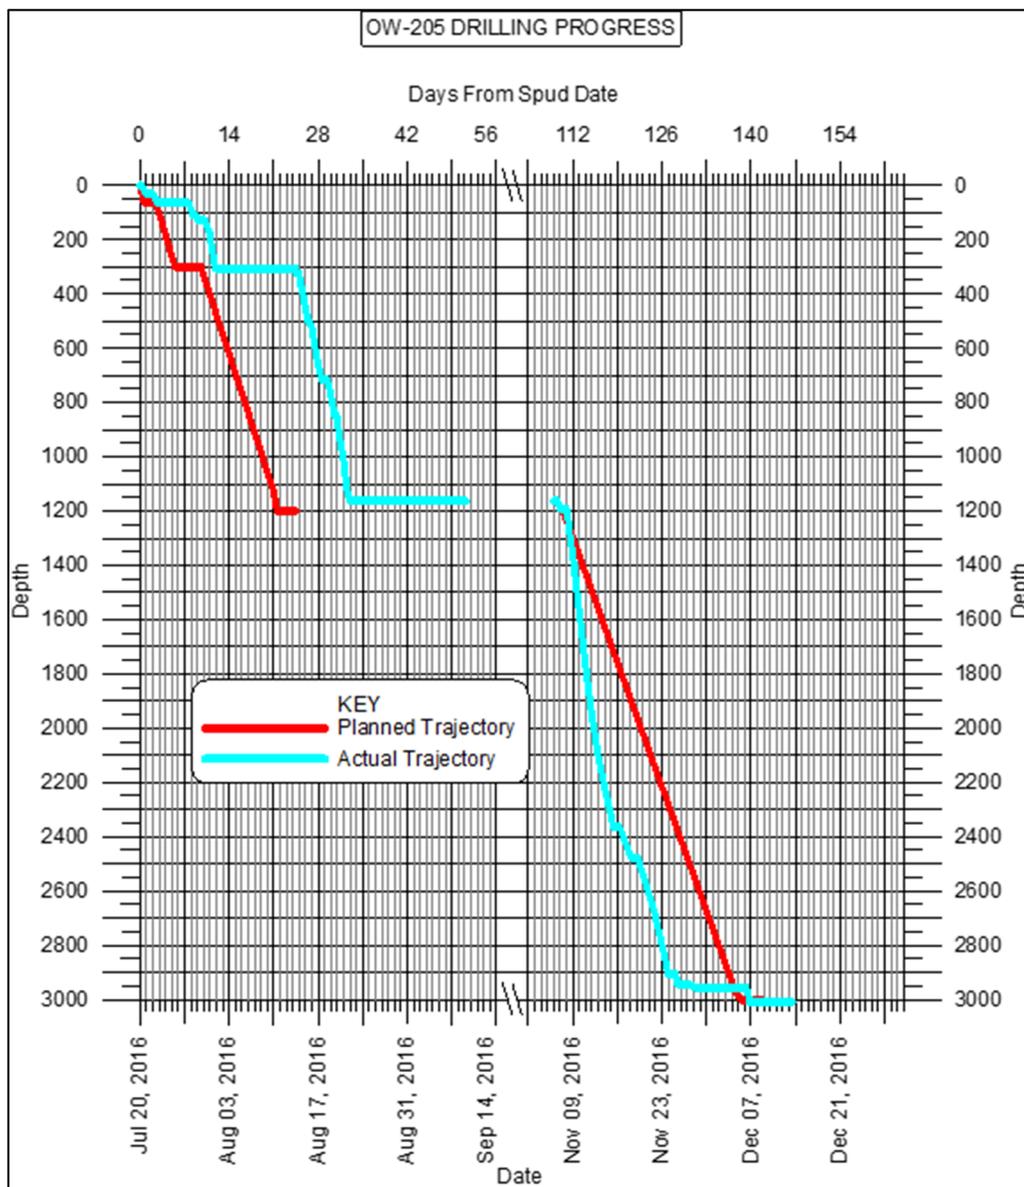
FIGURE 10: Well OW-205 drilling progress (KenGen, 2016)

The stuck pipe incidence at 108 m during drilling and 174 m during trip out could be associated with inadequate hole cleaning. There were no circulation returns from below 90 m RKB. The formation in this zone was mainly composed of pyroclastic rocks (water as a circulation fluid). Prior to the two incidences, there were repairs of surface equipment. The lifting clutch for the draw works, the rig motor engine, the slush pump and the compressor showed malfunctions and had to be repaired. All these delays could have contributed to the settling of cuttings in the wellbore. Tripping out of the drill string could have caused friction with the weak unconsolidated pyroclastic formation leading to its collapse.

At 2954 m, the stuck pipe could have easily been caused by running a full gauge bit into an under gauge hole previously drilled by a worn out bit. This could have been avoided by reaming the suspected under gauge section especially if the previous bit came out under gauge.

MD (m RKB)	Changes in torque	Changes in WOB	Changes in ROP	Circulation returns	Stuck pipe Indication	Possible cause of stuck pipe
108	Increase	Unchanged	Unchanged	Absent	After conducting repairs on draw works, there was no movement of string	Pack-off caused by in-adequate hole cleaning leading to settlement of cuttings
305	Trip out	Trip out	Trip out	Absent	Increase hook load and drag while tripping out at 174 m RKB	Pack-off caused by in-adequate hole cleaning leading to settlement of cuttings
2954	Increase	Unchanged	zero	Absent	Happened immediately after RIH with a new bit	Well geometry: The old bit could have been slightly under gauge.
