**Hydrothermal Eruptions During Excavation
of a Seawater Pump Sump at Bouillante**

Greinargerð Sverrir-2003/02 / SP-2003/02

19.03.2003

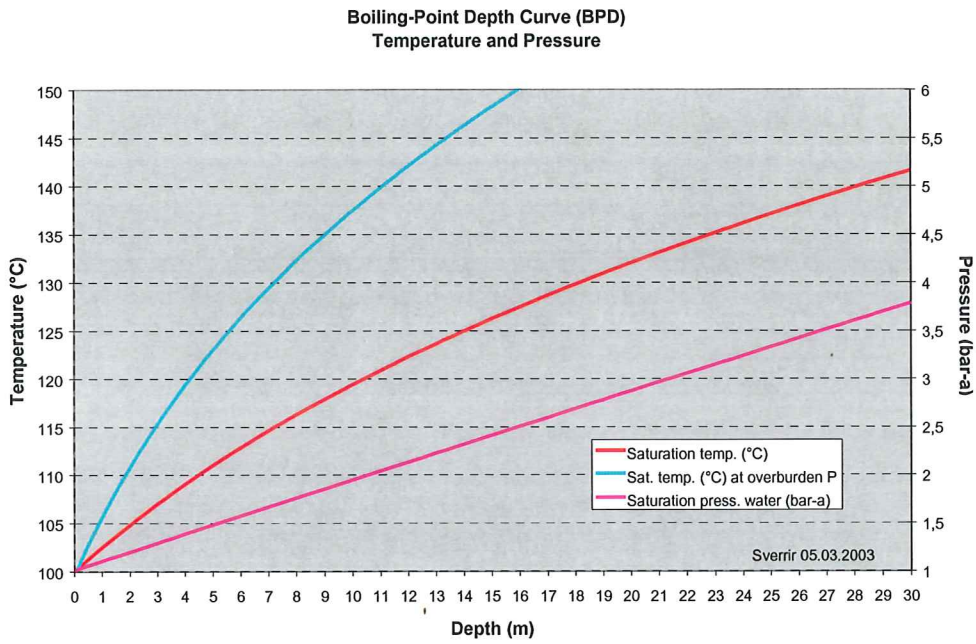
Figure 1. Diagram sent to CFG prior to the trip to act as a guide to assess the danger of a blow-out. Wells with temperatures below the boiling point (BPD curve) are stable. The red line BPD curve can be considered as the “maximum” temperature vs. depth and is often found in natural high-temperature geothermal systems.

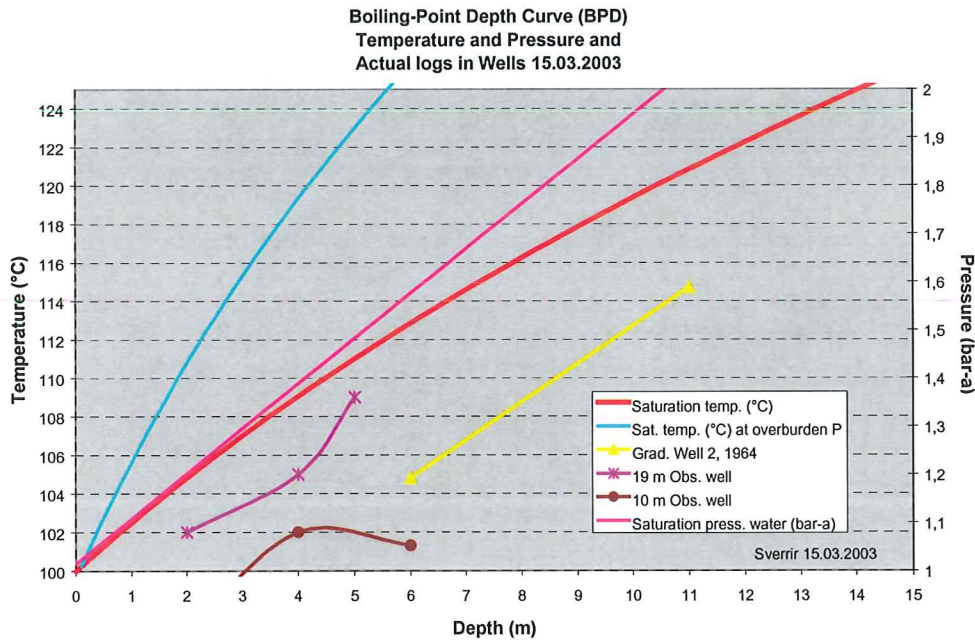
Figure 2. This diagram includes the same guidelines as fig. 1 but shows the temperatures logged in observations wells by the sea water pit 15.03.2003. All of the wells have temperatures below the BPD curve when the pit is full of water but do become unstable once the water level drops much below 2 m from the present.

- Maintain the pit FULL of water until the bottom can be secured by cementing.
- The temperature at 6 m depth, the intended excavation depth is about 110°C and the saturation pressure is about 1,4 bar-a. This means that a water level of 4 m H₂O has to exerted at -6 m depth to avoid flashing. As the water level in the full pit is at about - 1 m there is a small overpressure of about 1 m H₂O as a margin of safety.

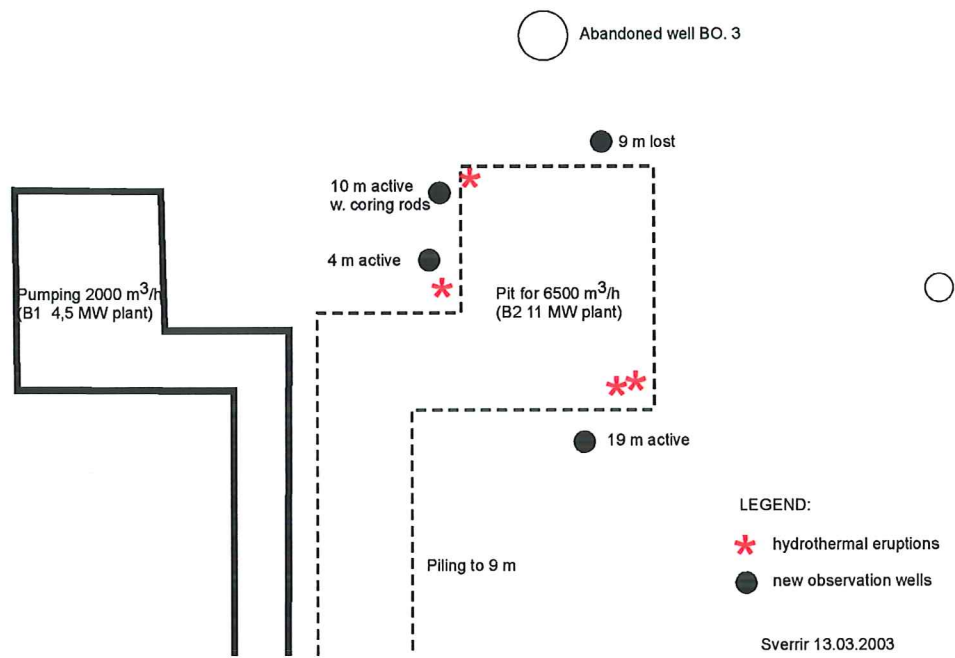
Figure 3. Figure showing where the hydrothermal eruptions occurred. Sketch made after a verbal description of Mr. Herlander Correia. Photographs showed the erupted material to be thick clay having the consistency of thick drilling mud. With this mud there was the release of steam. The eruptions started on February 20th and lasted as short time - a sort blast.

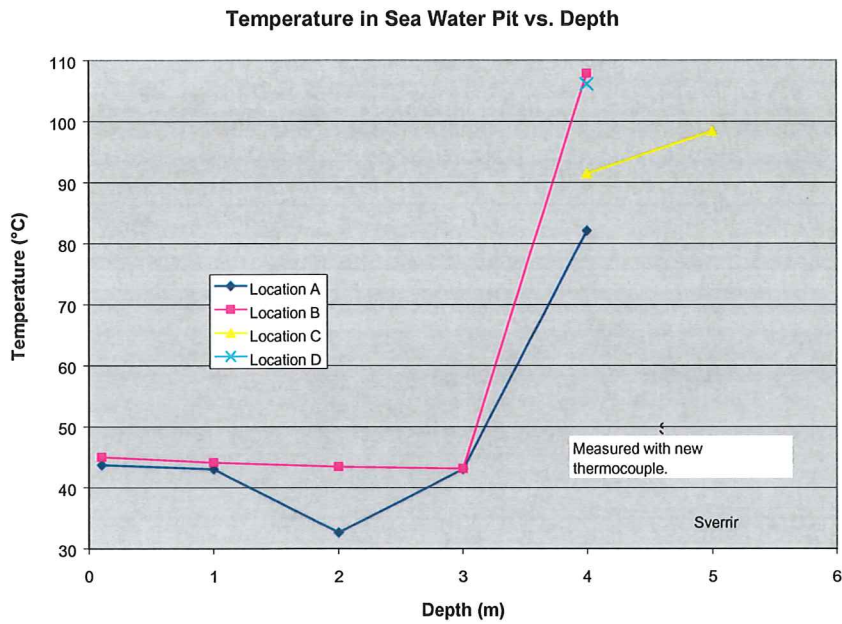
Figure 6. Temperature measurements made in the sea-water pit 15.03.2003. The water in the pit is relatively cold suggesting small inflow with the pit full of water. The bottom readings were made by thrusting the temperature probe some 20 cm into the soft bottom layer. The temperature there approaches 108°C m at 4 m depth. For location of measurement sites in the pit and approximate location of the wells see fig. 5.

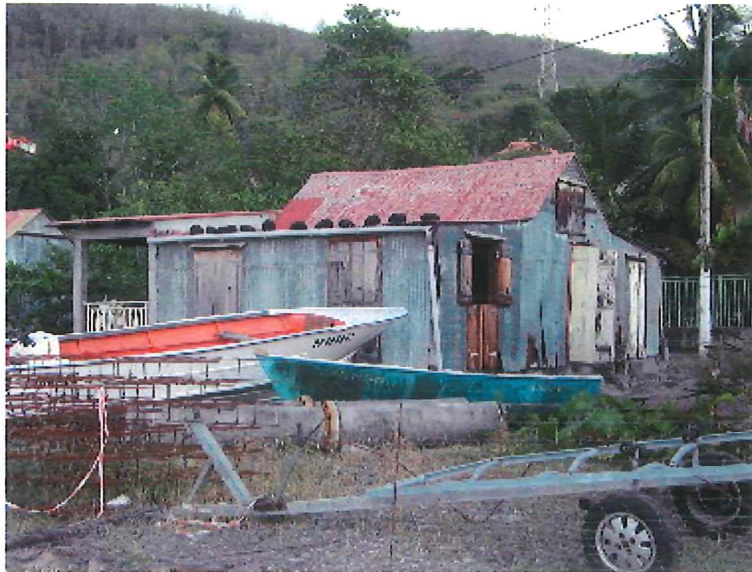
Photo 3. A house near the pipeline where the floor is hot and deposits on the outside of the foundations. The stone stairs to the main door under the window issue steam at 98,9°C.

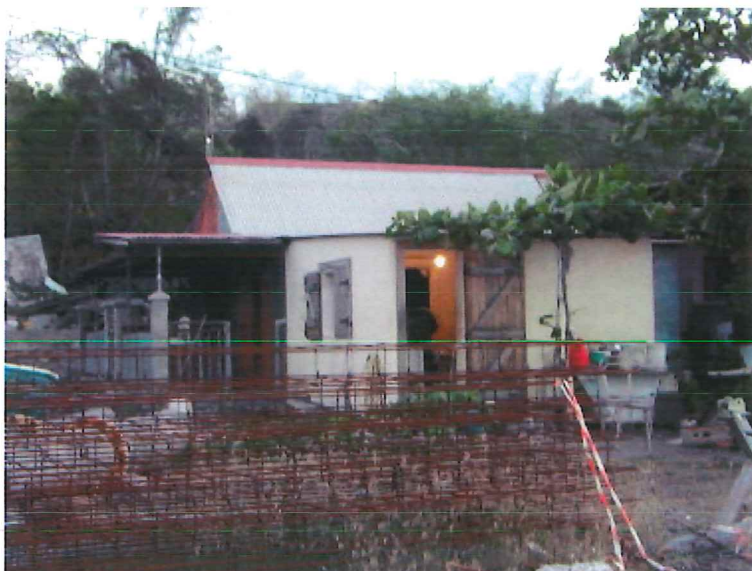
Photo 4. Another house next to photo 3 with a warm floor. The living room floor in the top left corner of the house measured 46°C. Other parts of the floor were warm as well.

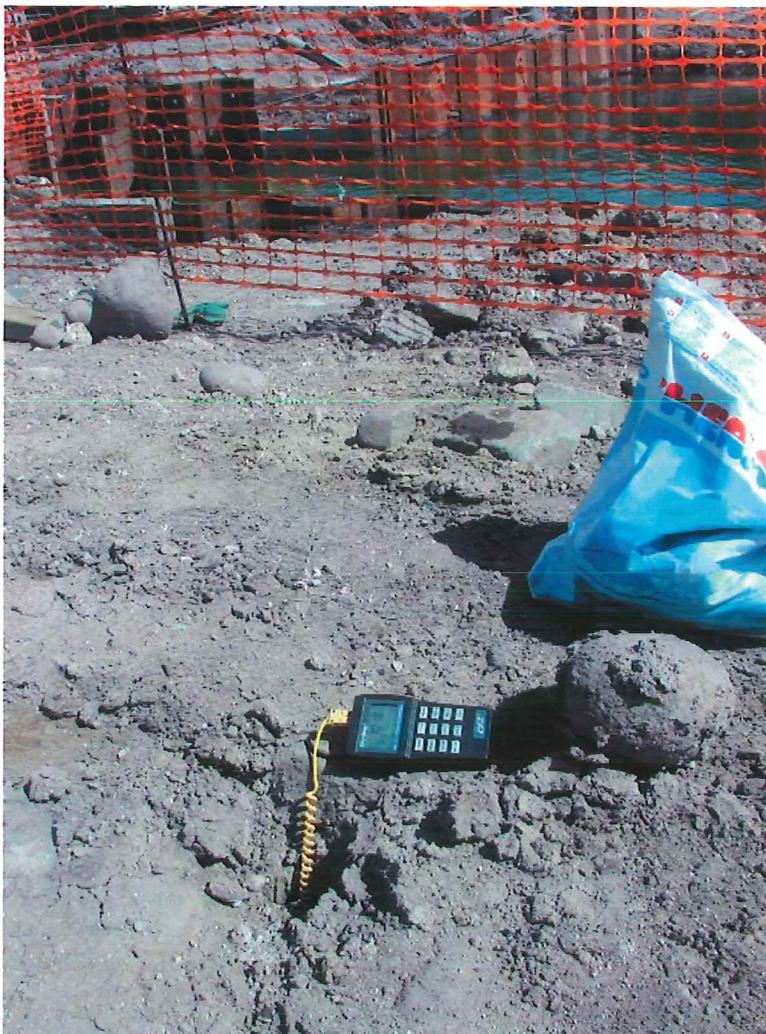
Photo 6. Shallow temperature reading in 19 m test well showing 101°C at 1 m depth.

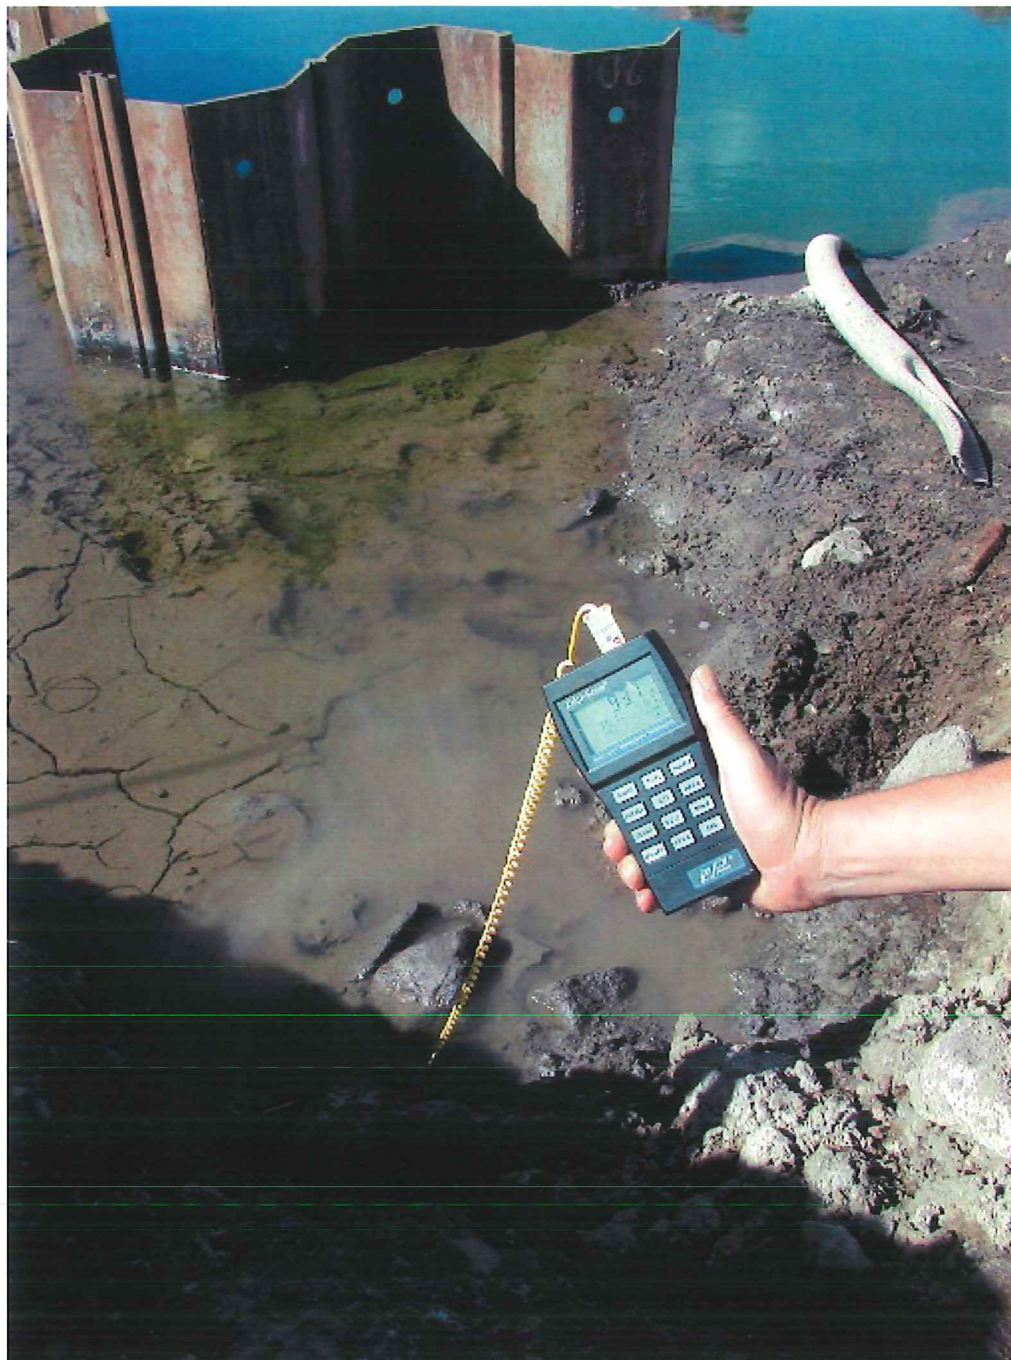
Photo 7. Hot mud (93,1°C) on surface just outside the steel piles. The mud is very soft and did not support the authors weight.

2. The area outside the pit has had the appr. 1 m thick landfill removed and is now at the level of the old shoreline. There is considerable thermal activity in this very soft clay ground. In spite of me taking precautions where I walked, one of my legs sank deep into the 83°C clay below. I was saved from burns by my knee-high rubber boots. This area needs to be secured by removing some more clay and then filling in with small rocks (separating the clay with geotextile?) and then filling up with compacted soil.

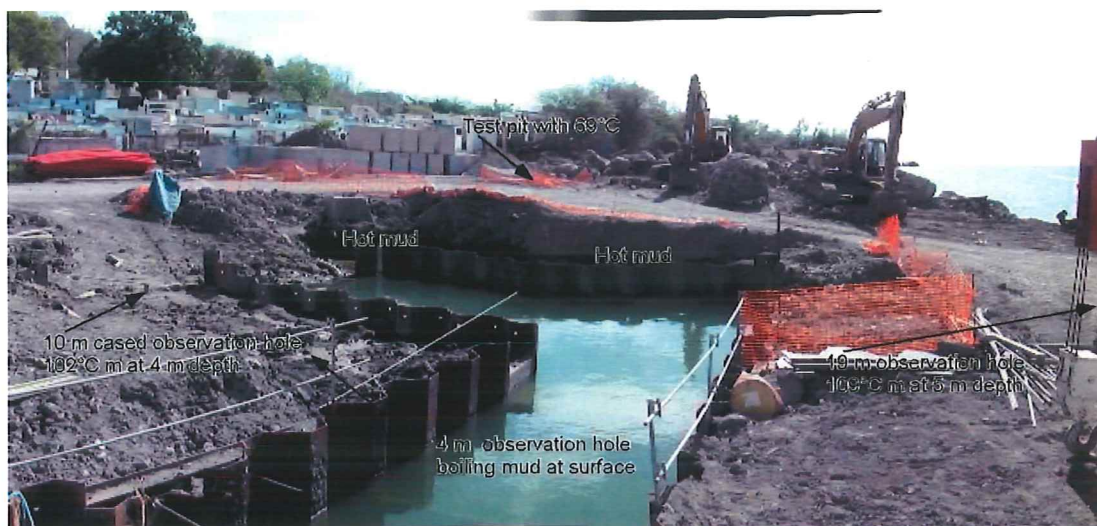
Photo 8. Photograph of pit showing position of hot spots and three observation holes.

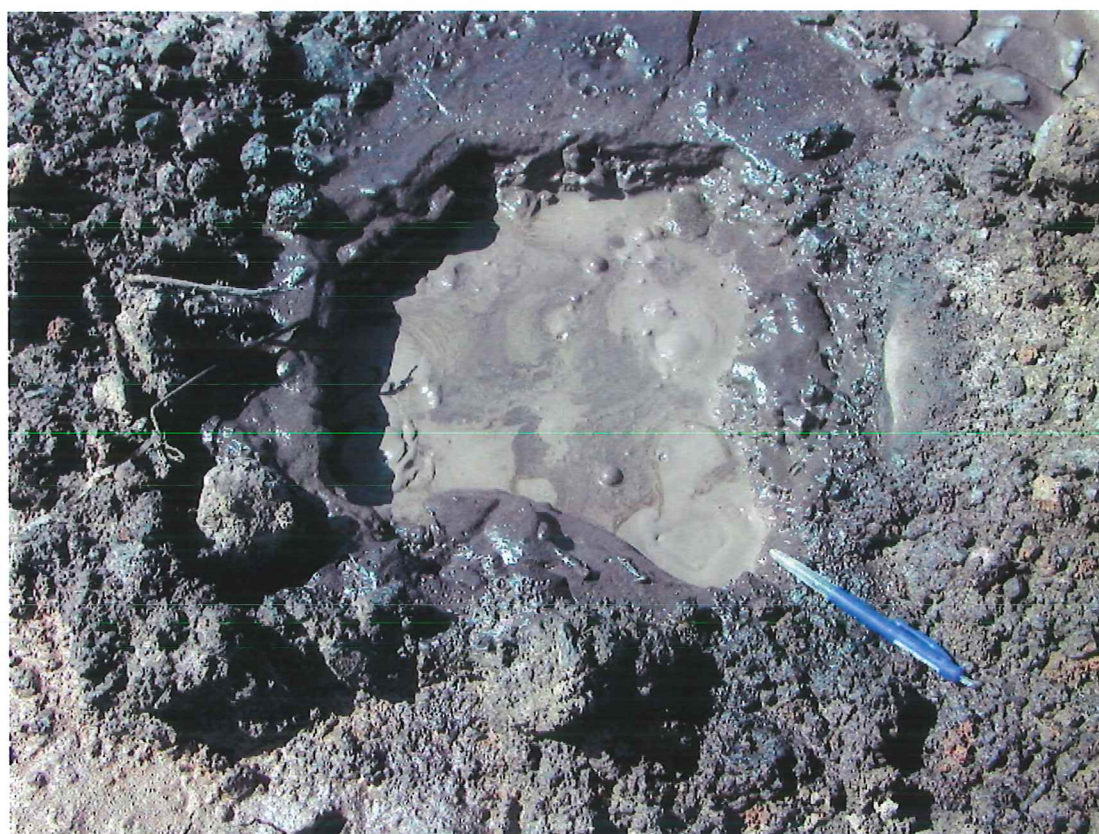
Photo 9. This is the boiling mud where the 4 m deep observation hole was drilled. Temperature measured 100°C so the bubbles are steam bubbles and not gas.

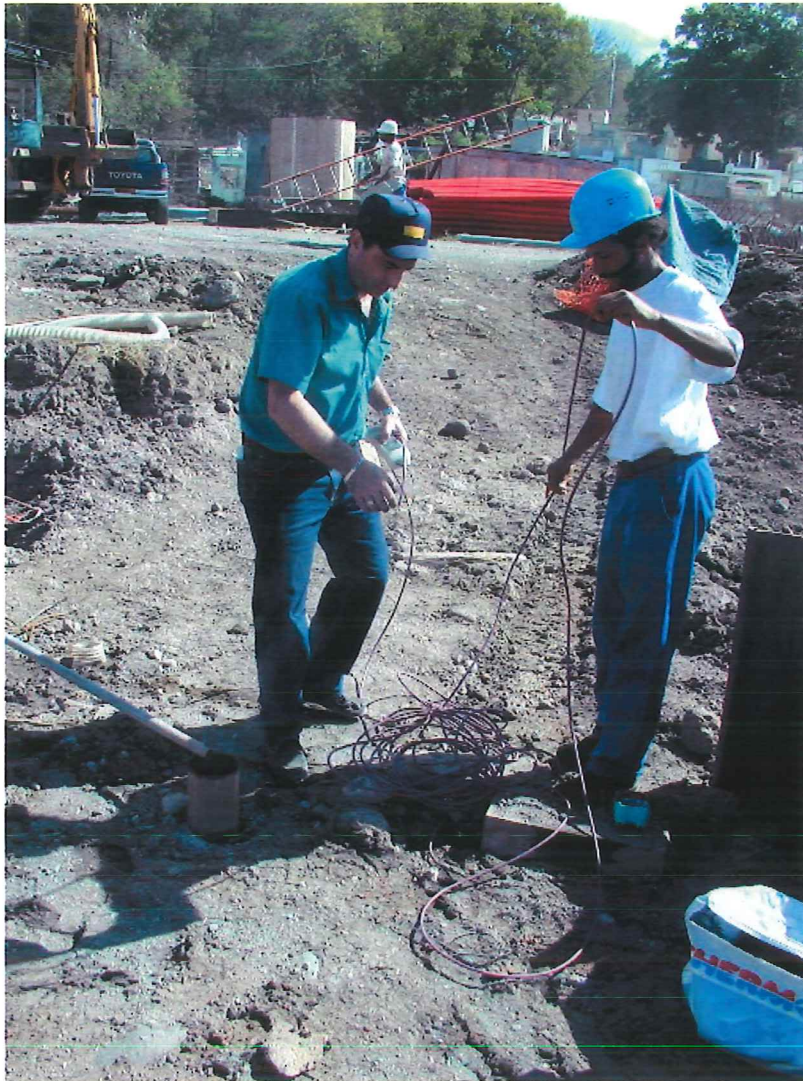
Photo 11. Logging of the observation hole with a thermocouple. The wire insulation failed due to poor temperature resistance of the plastic isolation tape.

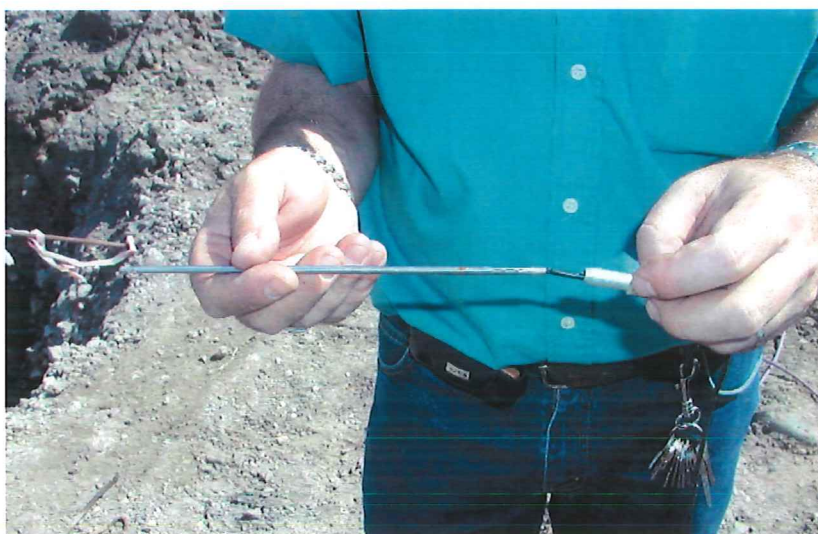
Photo 12. Close-up of failure of thermocouple wire.

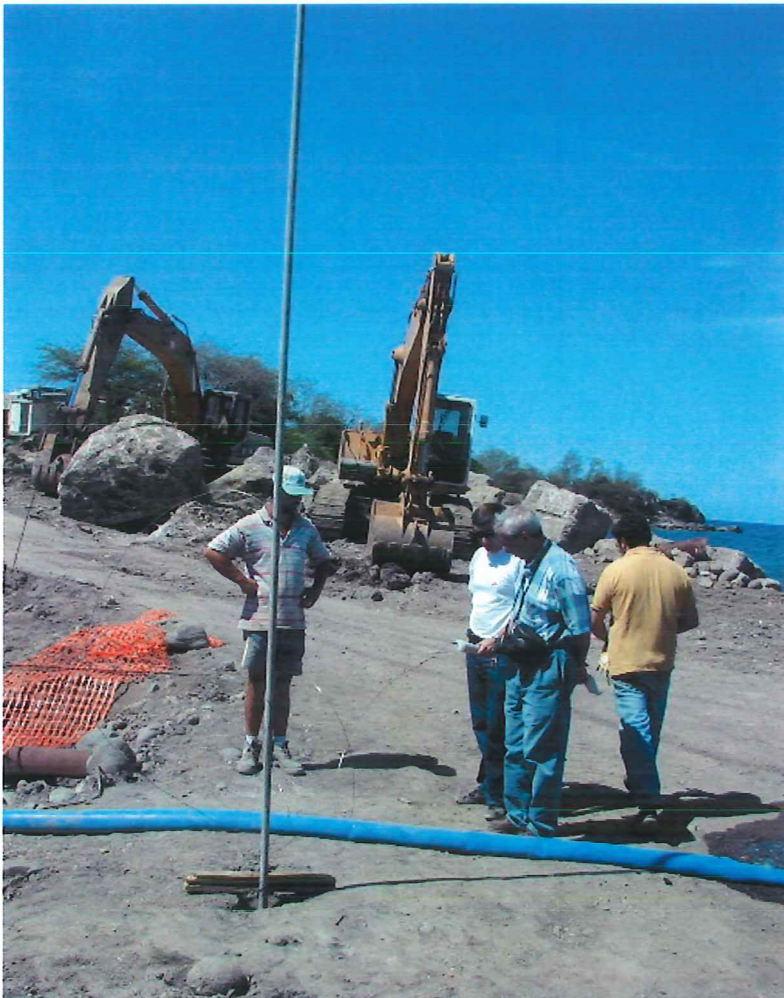
Photo 14. An encapsulated thermocouple wire strapped to a pipe finally worked.

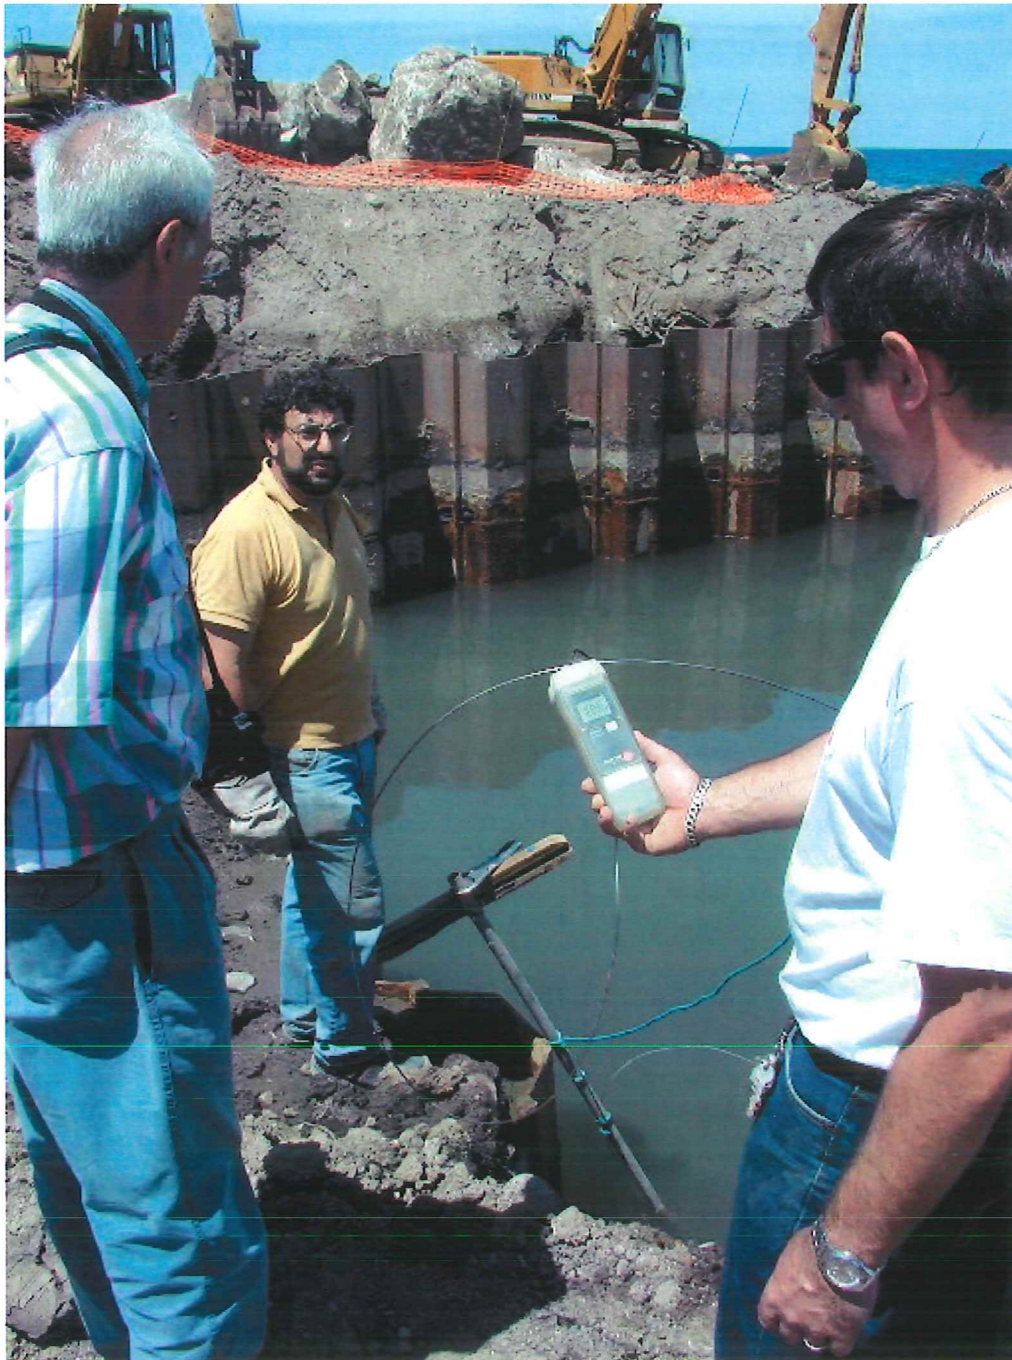
Photo 15. Temperature reading at location B in the bottom of the pit where the highest readings were obtained, 109°C at 5 m depth. When the picture is taken the reading is 104.5°C. Note the total length of the pipe that the thermocouple wire is strapped to is 6 m long.

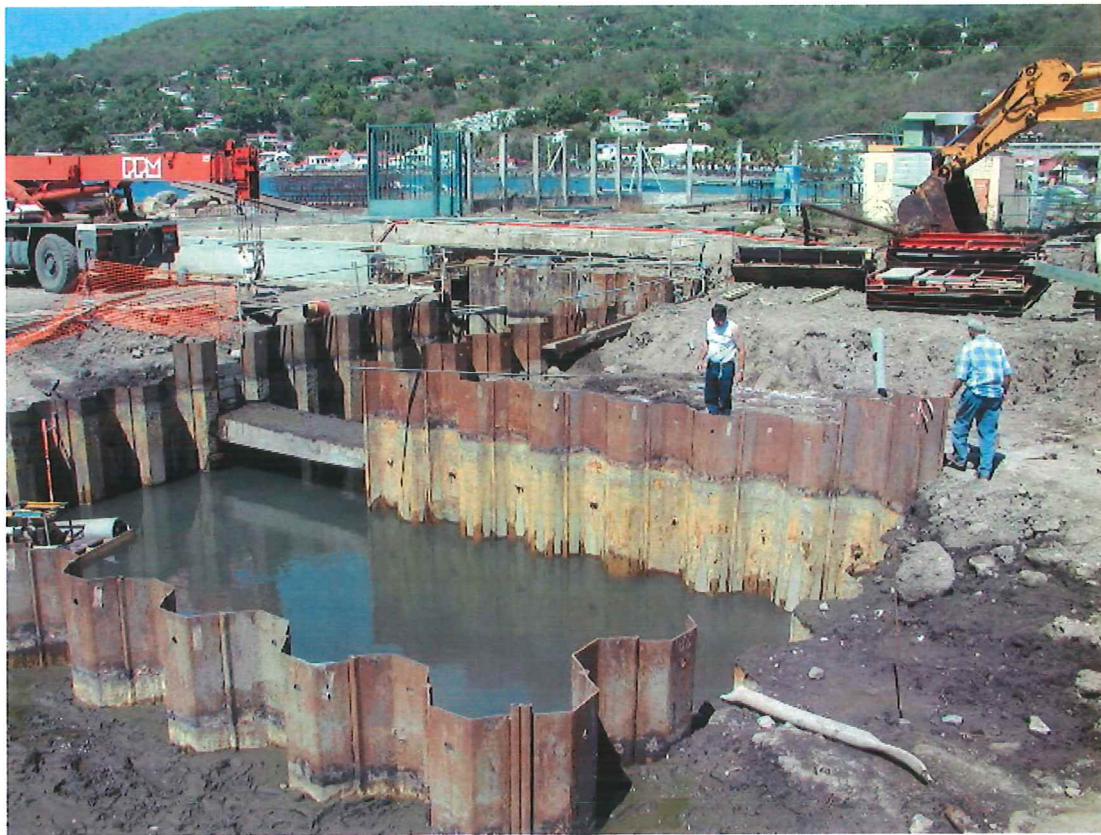
Photo 16. Photograph of the pit Saturday 15.03.2003 after being drained by pumping. There was no increase in thermal activity during this period. Only a few gas bubbles were surfacing near the pump barge.

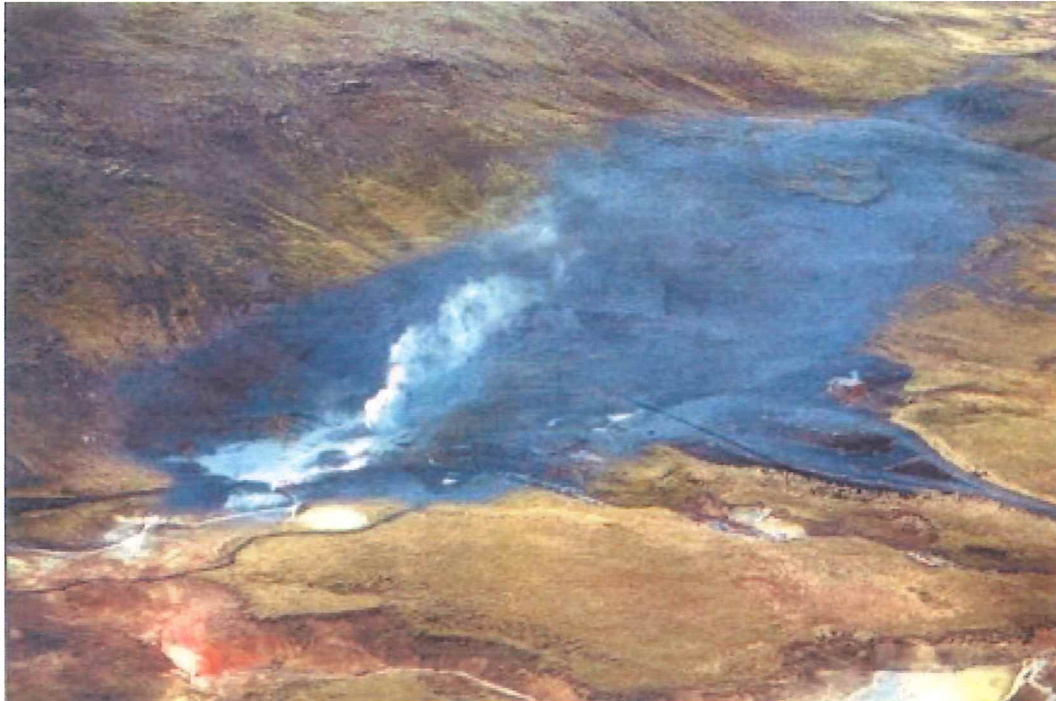
Photo 17. Hydrothermal eruption at Krýsuvík Iceland. Hot mud was thrown into the air and carried for 200 m. This photograph is taken from an airplane shortly thereafter.

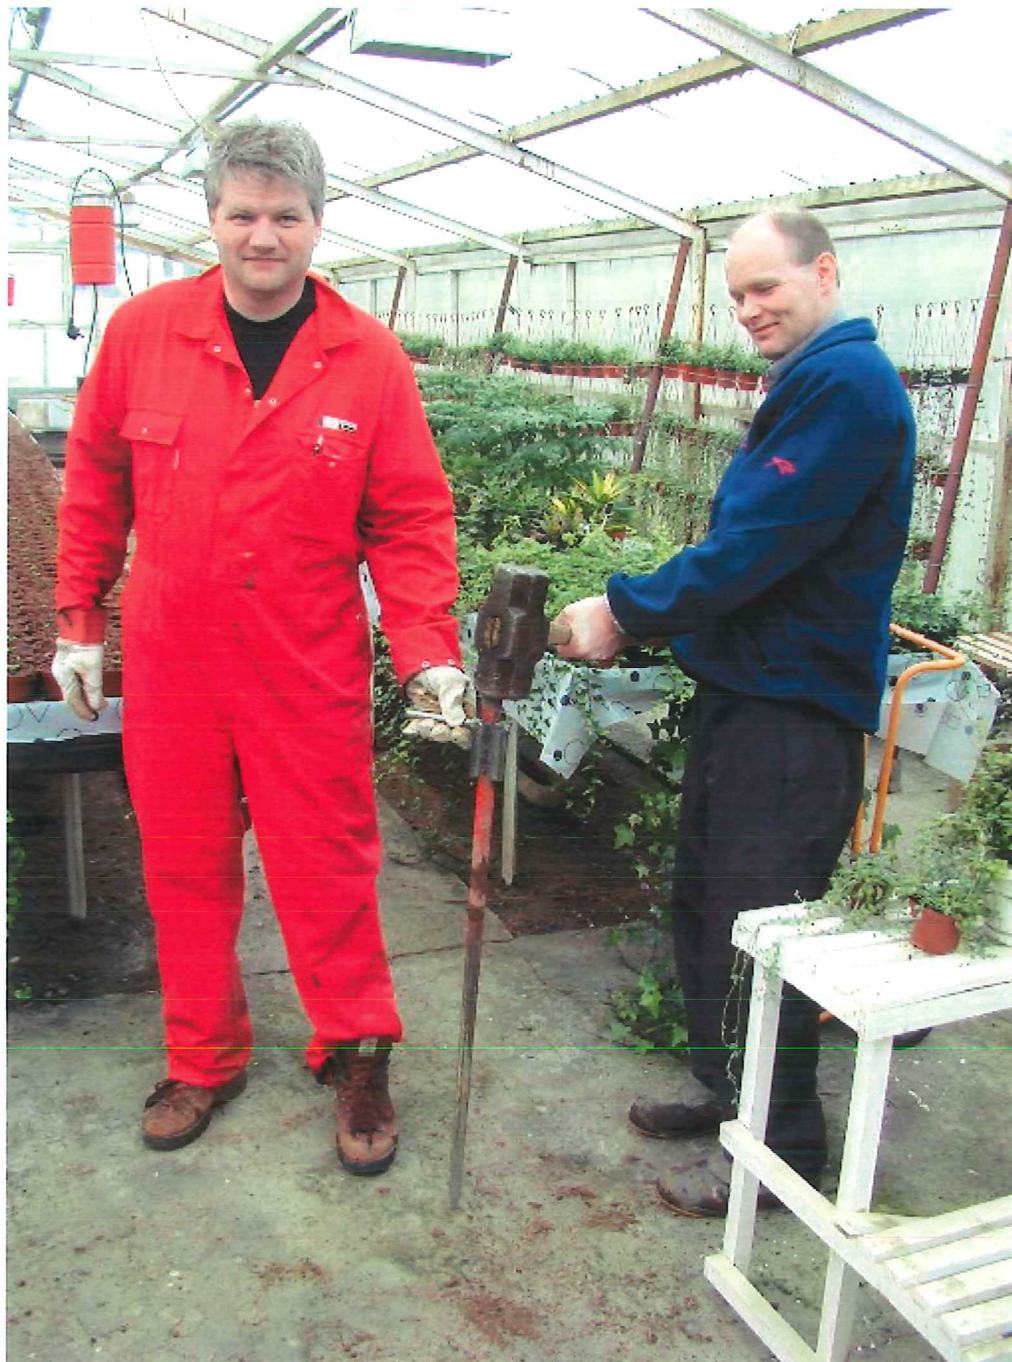
Photo 19. A steel chisel is first driven into the ground with a big sledgehammer to make a pilot hole for the temperature probe. The chisel is removed and the hole stays open. After temperature equilibration the temperature probe is lowered into the hole for the reading. Depth of reading in firm soil is usually 60 cm.

3. In order to get a clear picture of the extent of hot ground it is recommended that a surface temperature survey be made. The lines should be laid out perpendicular to the suspected fault or controlling structure. In Iceland, where such surveys are used for the same purpose, the lines are 20 m apart and the measuring points spaced at 5 m. Where straight lines are not possible due to obstructions randomly selected sites are used to give good coverage. First a survey hole is made by a 20 mm pin is inserted to a fixed depth in the range 60-80 cm, sometimes aided by a hammer, and then shortly thereafter the 15 mm dia. temperature measurement probe is inserted for the reading. Such ground temperature surveys may be supplemented by aerial infrared surveys or by remote sensing from satellite. This is furthermore an inexpensive way to monitor any long term changes in the environment. Had such surveys been available, they could have influenced the siting of the pump station and would now allow evaluation of alternate sites, should the present site have to be abandoned.

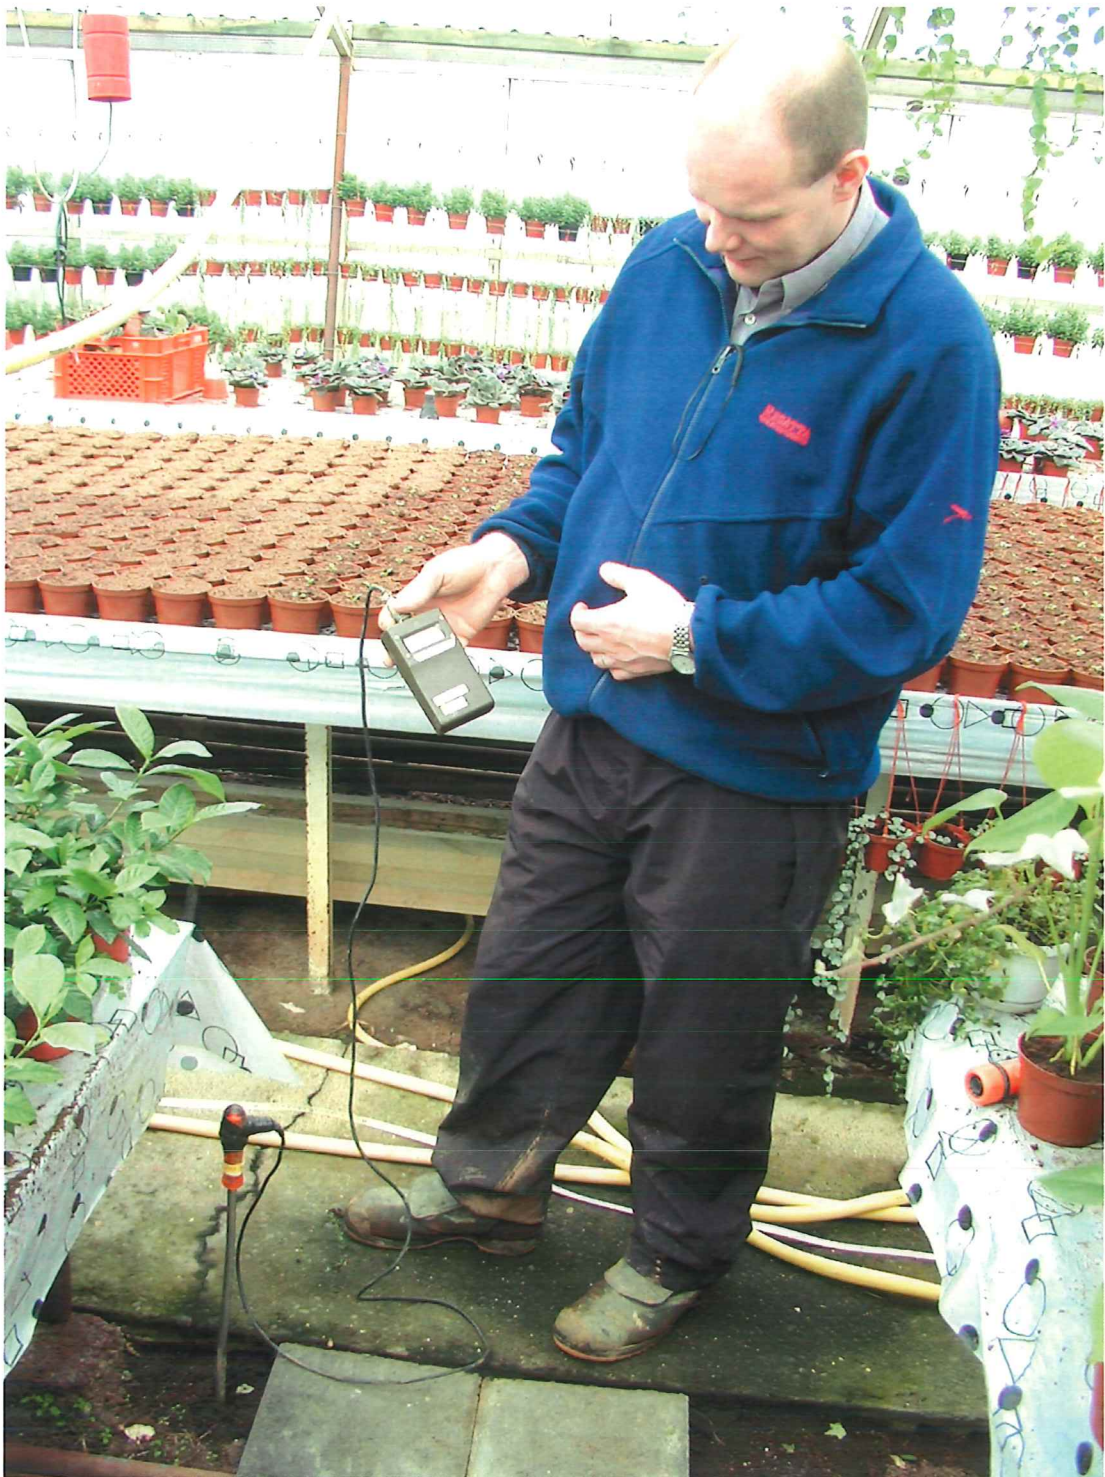
Photo 20. The temperature reading is made.
