ENGINEERING GEOLOGY  
of the  
HVITA and THJORSA BASINS,  
ICELAND

Allen H. Nicol  
United Nations Special Fund

October 1965

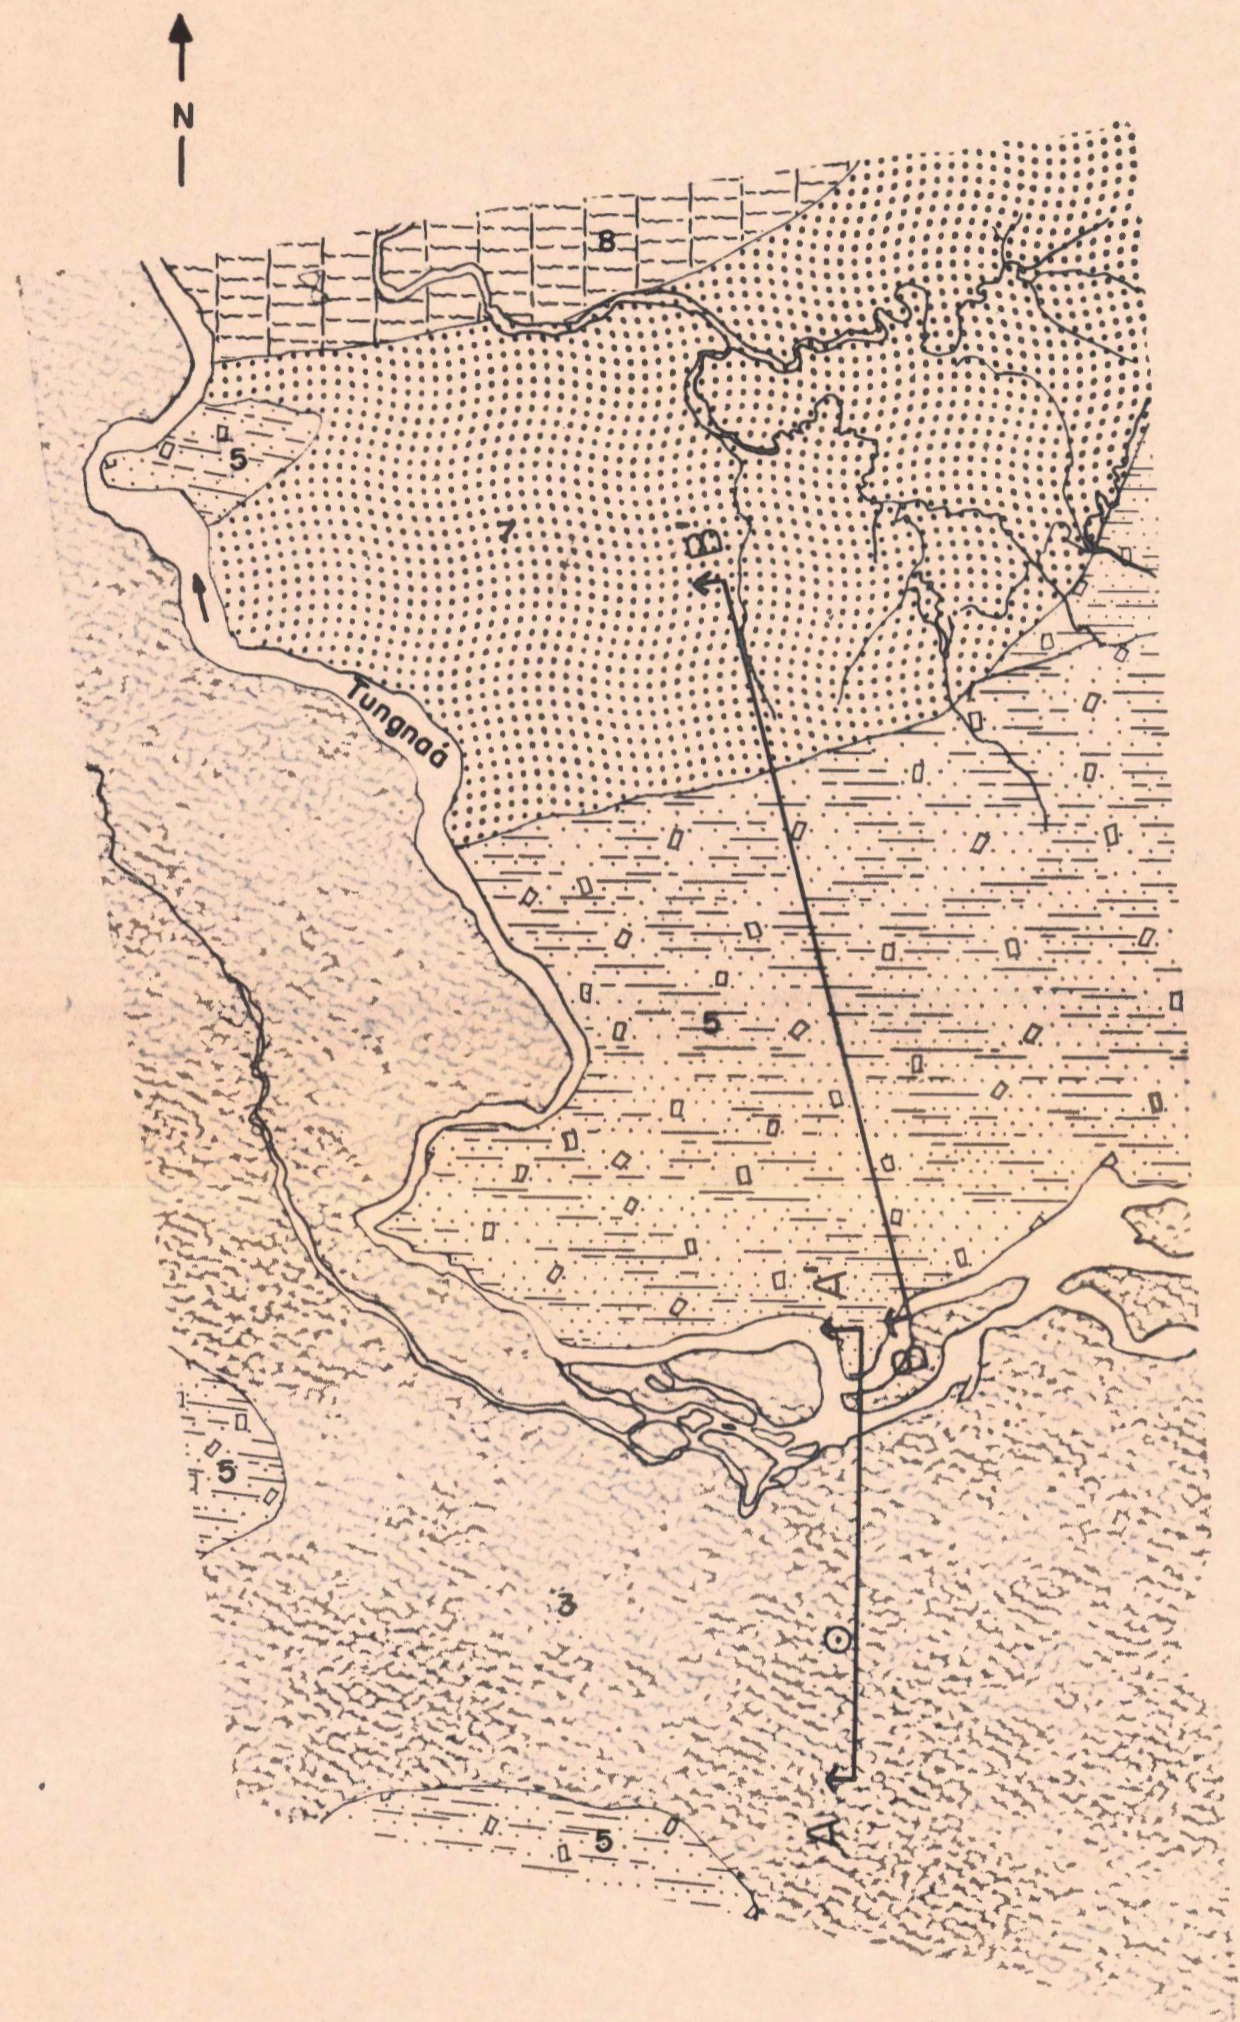
T-15 HRAUNEYJARFOSS  
 GEOLOGIC MAP AND CROSS SECTIONS  
 THE STATE ELECTRICITY AUTHORITY, ICELAND  
 UNITED NATIONS SPECIAL FUND  
 REYKJAVIK, ICELAND

- ↔ LOCATION OF CROSS SECTIONS
- ⊙ APPROXIMATE LOCATION OF DRILLHOLE
- FOR EXPLANATION OF MAP UNITS, SEE FIG 2
